LIMITED ASBESTOS AND LEAD-BASED PAINT INSPECTION REPORT
FORMER FLORENCE POST OFFICE

Florence, South Carolina

Asbestos Inspections, LLC Project # 2017-30

Report Prepared On – February 22, 2017

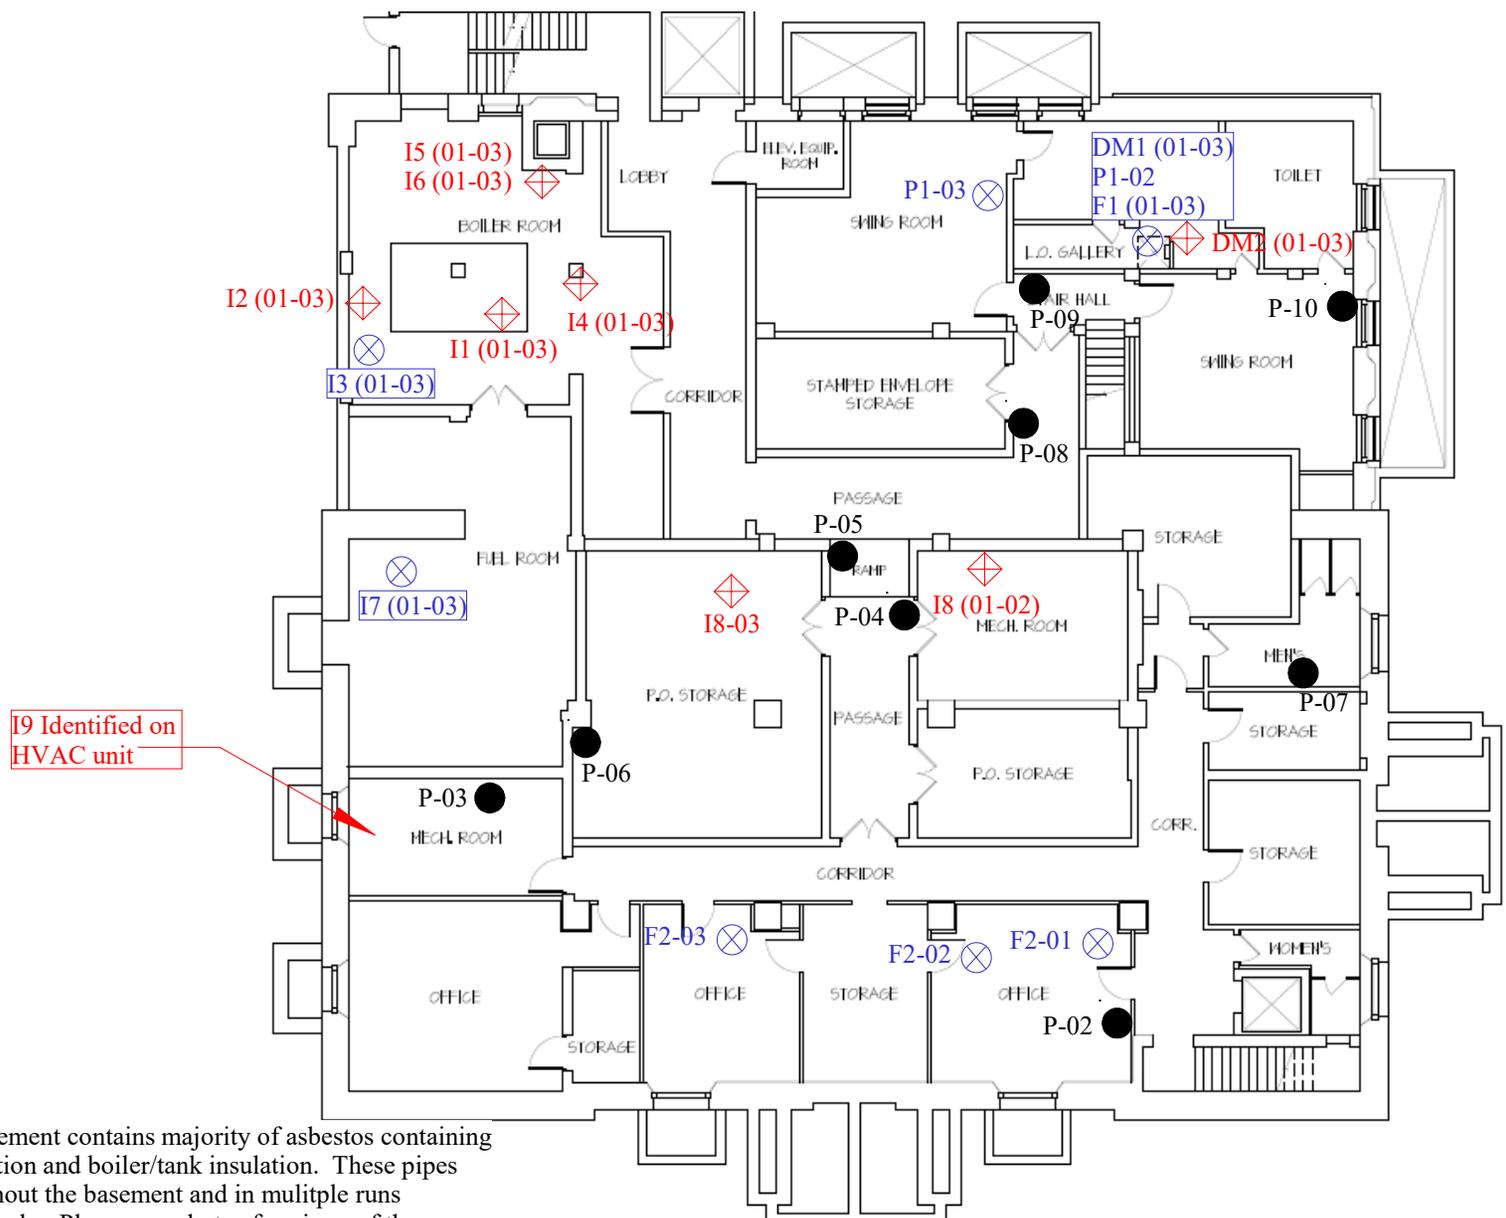
Notes: Basement contains majority of asbestos containing pipe insulation and boiler/tank insulation. These pipes run throughout the basement and in multiple runs simultaneously. Please see photos for views of these areas.

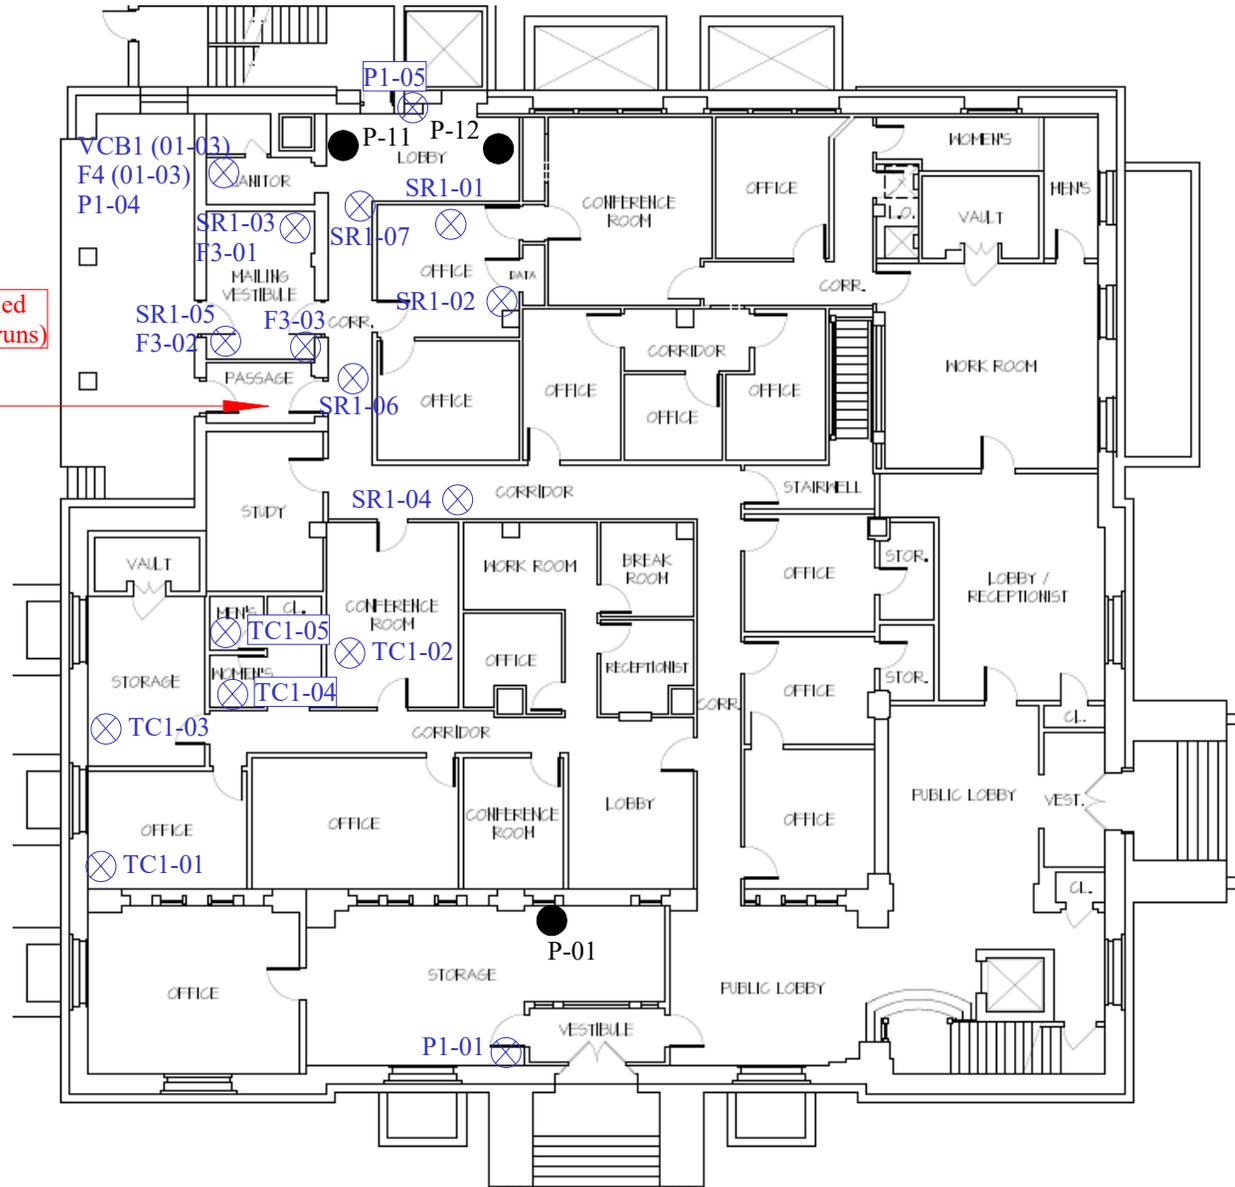
1st Floor

I2 was identified in passage (4 runs)

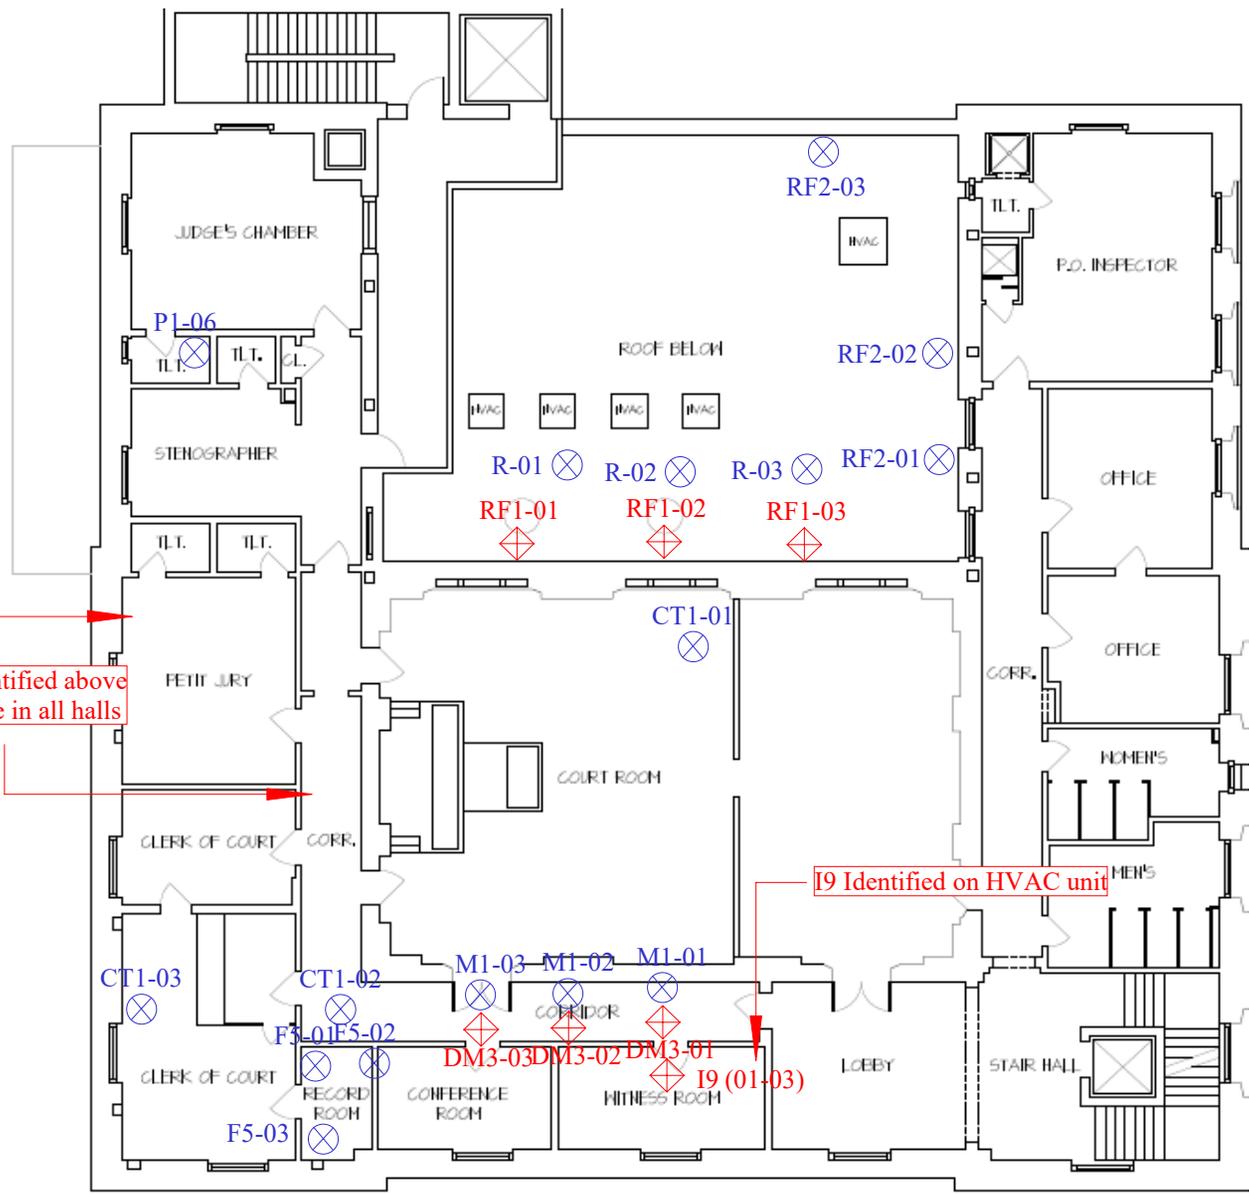
2nd Floor

I2 Identified in ceiling of 2nd floor rooms

DM3 Identified above ceiling tile in all halls

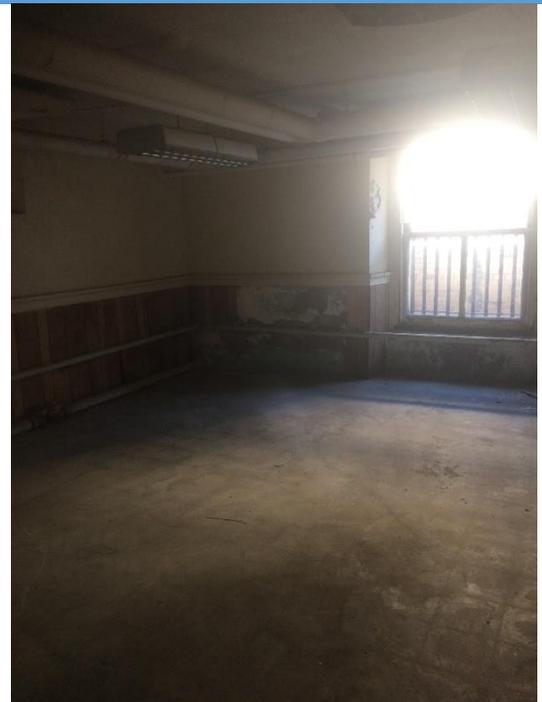
Basement front left office – pipe insulation in ceiling (multiple runs)

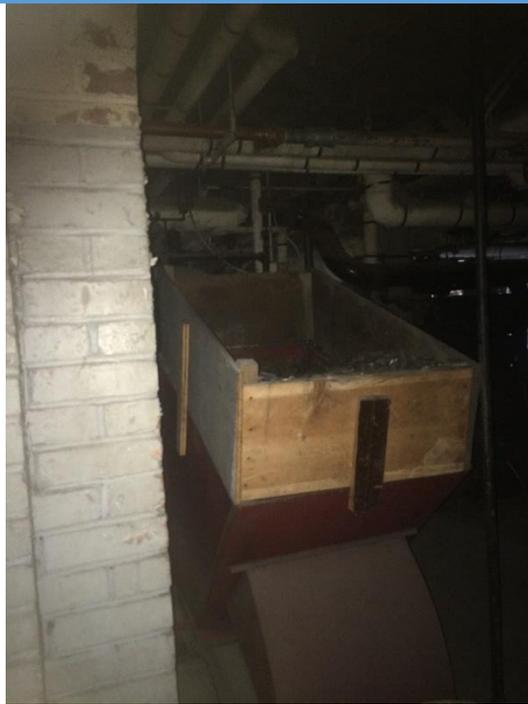
Basement – boiler room showing multiple runs of pipe insulation

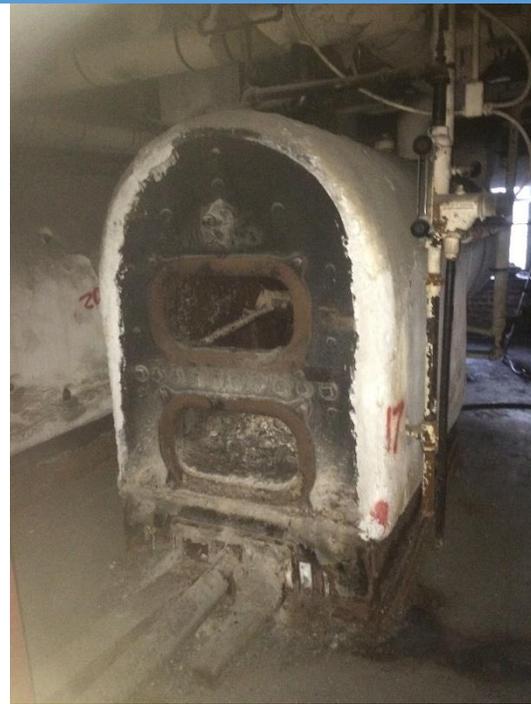
- I1 – Boiler insulation in basement (approximately 500 sf)
- I2 – Pipe insulation wrap to include elbows in basement and throughout other areas such as 1st floor passage and 2nd floor rooms (approximately 2,500 lf). No pipe insulation was observed on the 3rd floor rooms or above the ceiling tile.

Boiler showing asbestos containing insulation and multiple runs of pipe insulation

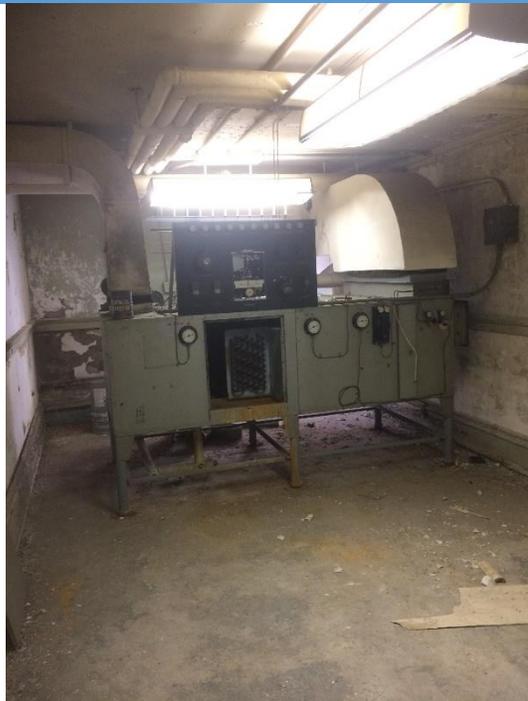
Basement mech room showing I9 and multiple runs of pipe insulation

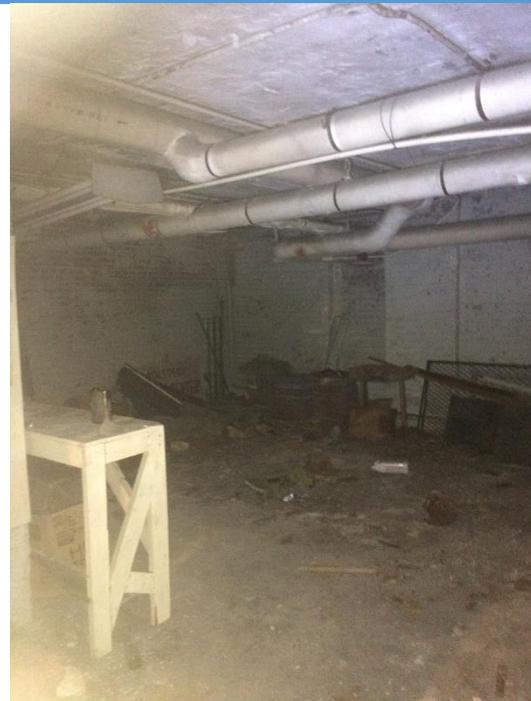
Basement P.O. Storage showing multiple runs of pipe insulation to include the chilled water line

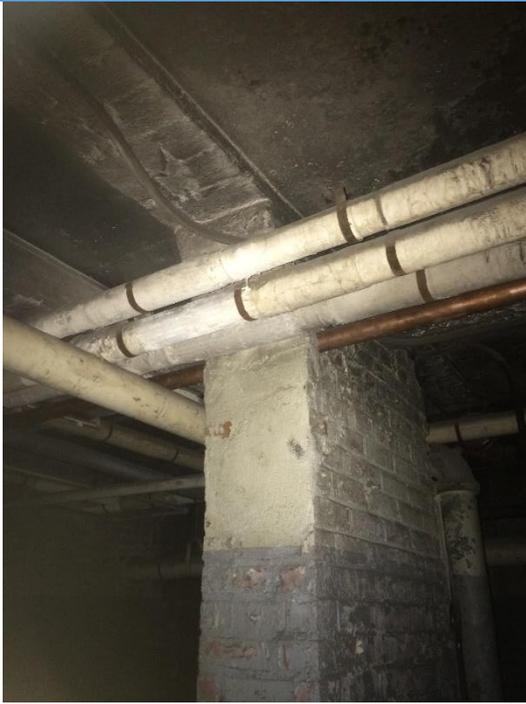
Basement – showing multiple runs of pipe insulation

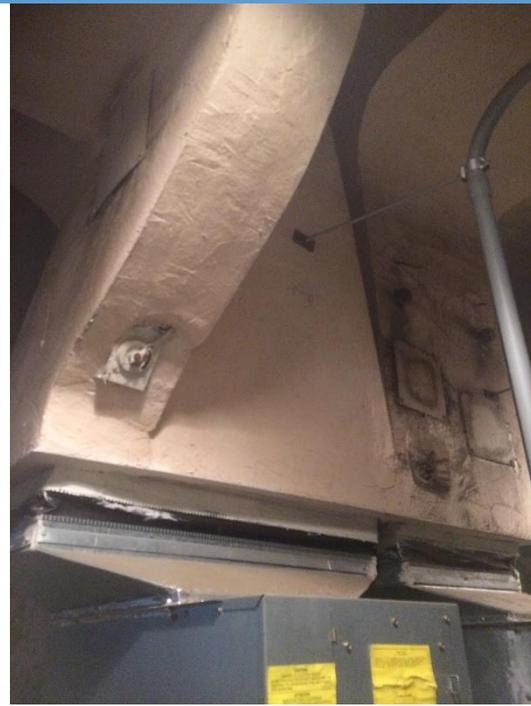
- I8 – Chilled water pipe insulation (approximately 600 lf)
- I9 – HVAC insulation 2nd and 3rd floor mechanical rooms and the attic (approximately 1,200 sf)

2nd floor HVAC insulation (I9)

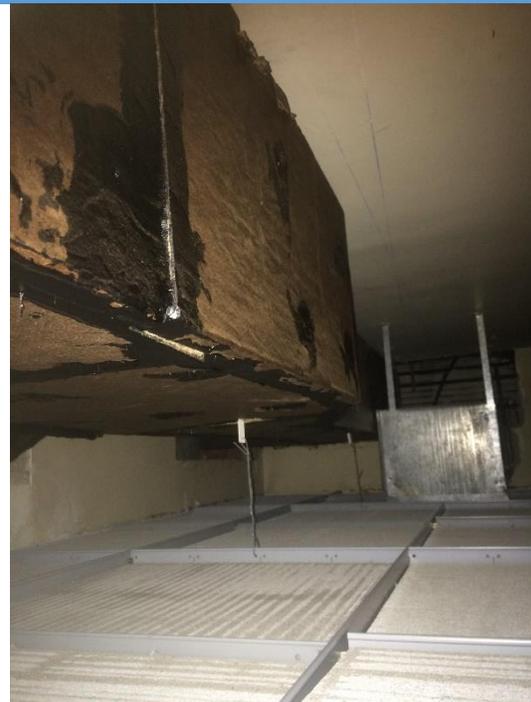
- DM2 – HVAC duct mastic in basement I.O. Gallery (approximately 50 sf)
- DM3 – HVAC duct mastic in 2nd and 3rd floor halls above ceiling tile (approximately 170 sf)

DM3 identified on HVAC duct above ceiling tile in 2nd and 3rd floor halls

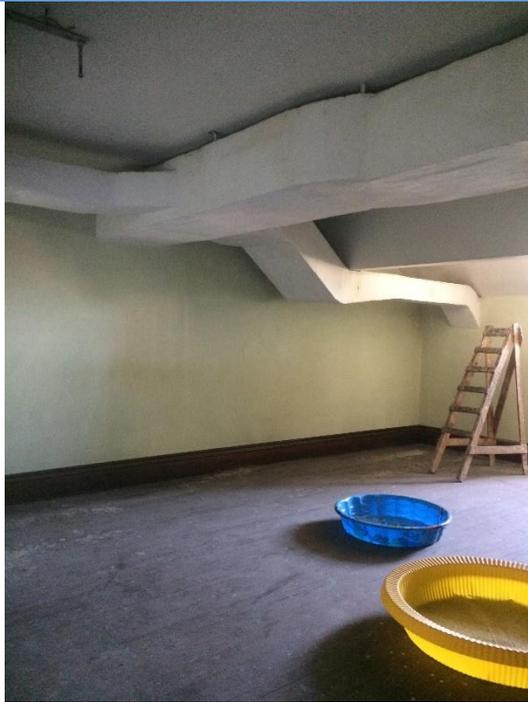
Room in attic showing HVAC insulation (I9)

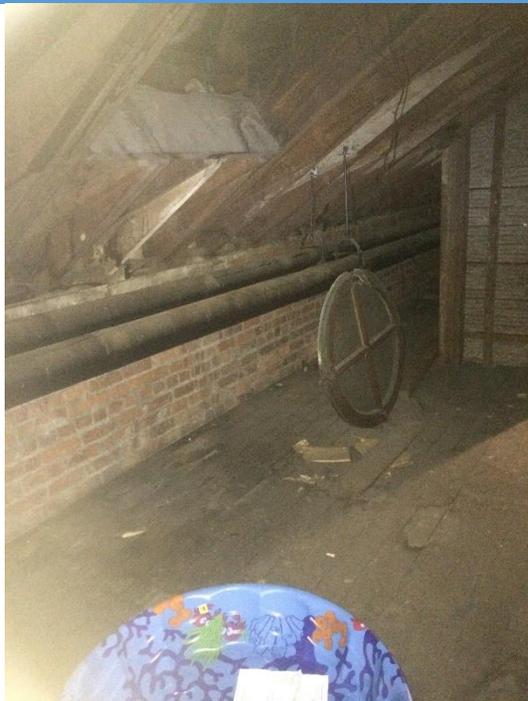
- I10 – Tar wrapped pipe insulation in attic (approximately 60 lf)
- RF1 – Silver painted roof flashing on 2nd floor roof (approximately 140 sf)

I10 in attic (asbestos tar on pipe insulation)

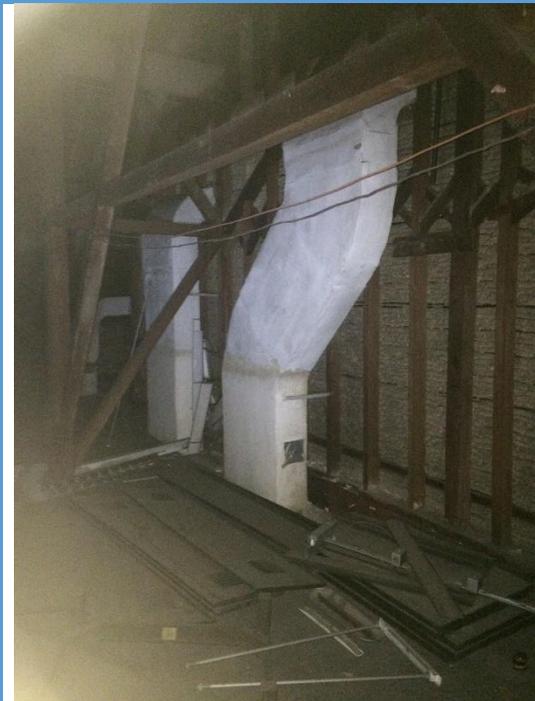
Another view of I9 in attic
