**REPORT OF
BUILDING CONDITION ASSESSMENT PHASE I**

**FORMER POST OFFICE AND COURTHOUSE
201 W. EVANS STREET
FLORENCE, SOUTH CAROLINA**

Prepared by:
GS₂ ENGINEERING, INC.
241 Business Park Blvd
Columbia, South Carolina 29203
GS 2 Project No.17-12967-F
March 3, 2017

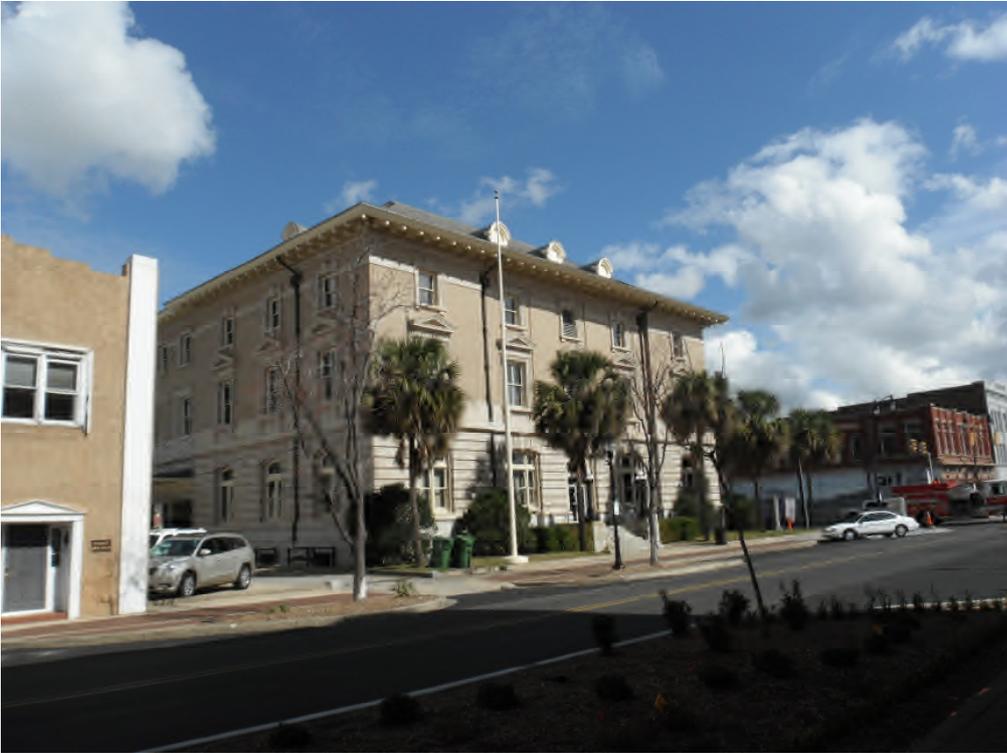
Photograph #1	Remarks

The facility is a 31,868 sf, three story building constructed in 1906. The exterior cladding system on the building consists of rusticated, cut and tooled sandstone base over smooth granite foundation. Monumental granite steps with cheek walls containing bronze lamp posts exist at the front and side entrances along W Evans and Irby Streets. The upper two floors consist of tan brick with limestone window and door surrounds and bulls eye dormers. (See Photos #1, #2 and #4). The building was listed on the National Registry in 1977.

Front and side (southwest corner of sandstone and brick over granite foundation) Second Renaissance Revival Style Listed in the National Register 1977.

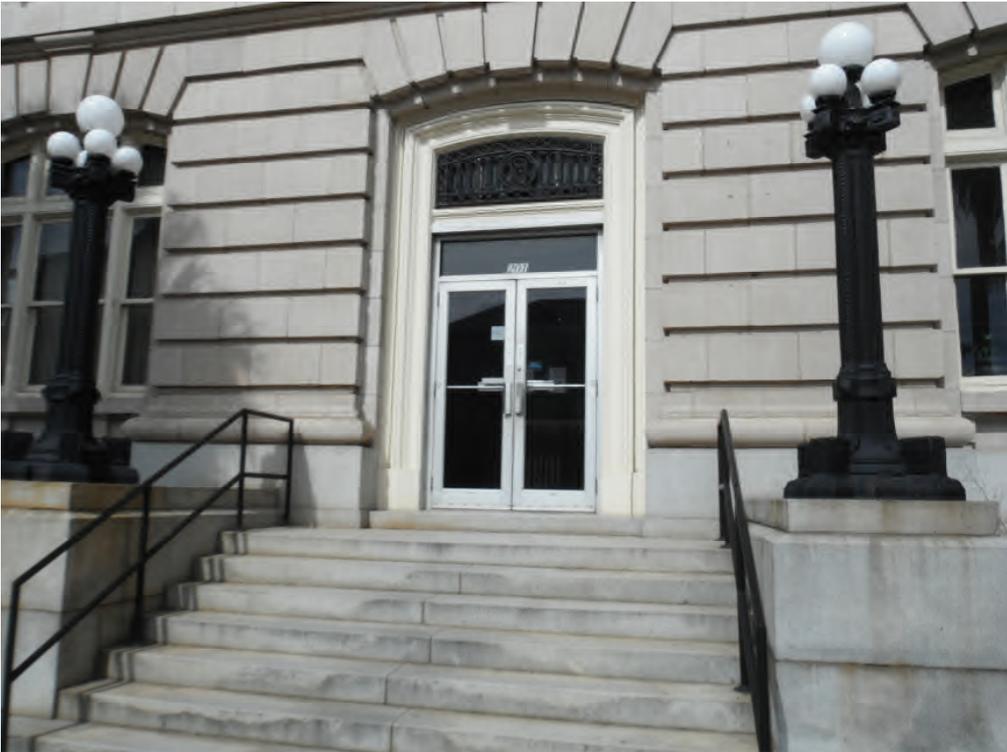
Photograph #2	Remarks

Landscaping and Appurtenances: Ornamental shrubs and grassy areas exist in front of the building. Landscaping appeared to be in good condition. The city's high intensity discharge (HID) lights are mounted on poles on the sidewalks and incandescent lights on bronze lamp posts exist on either side of the front and side entrances. Incandescent lights exist over the rear entrance under the canopy and one HID light was observed at the corner of the west elevation canopy. Exterior lighting was not observed in operation at the time of the visit. (See Photos #2, #8 and #12).

Main entrance with granite steps, cheek walls containing bronze lamp posts, aluminum double doors with single hand pulls

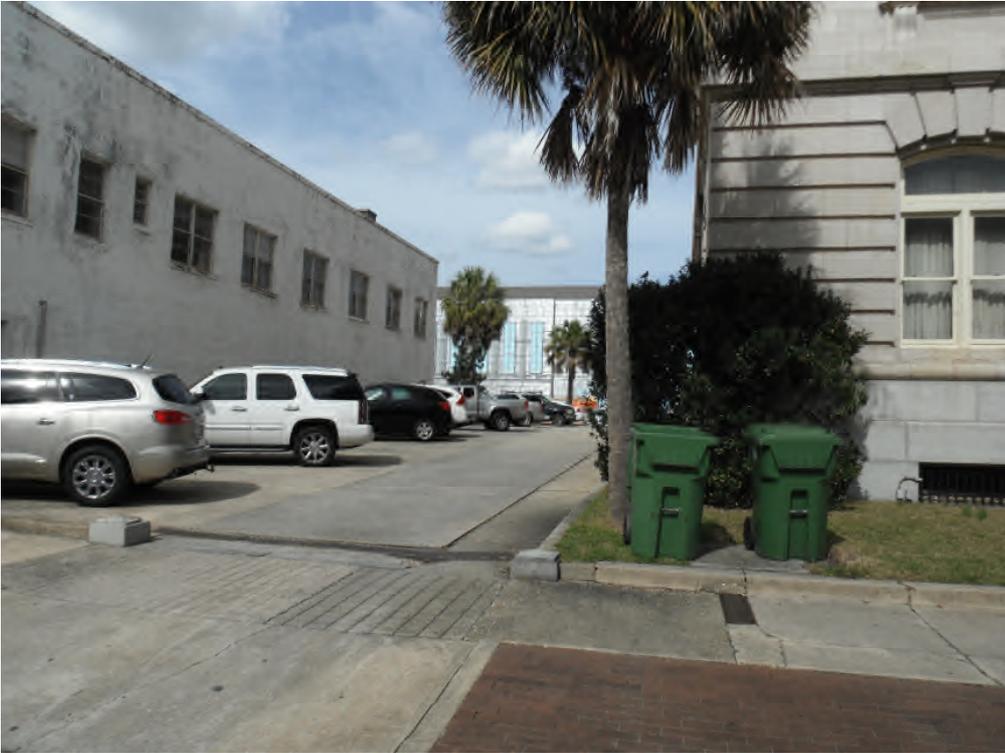
Photograph #3	Remarks

The parking area appears to be in average condition but not ADA compliant. The concrete pavement was observed to be patched and cracked in places. Parking striping has faded and is in the need to be redone. (See Photos #3 and #7). The adjacent public parking lot to the north can provide for the majority of the visitor's parking requirements.

Side elevation, (West) with visitor concrete paved parking area

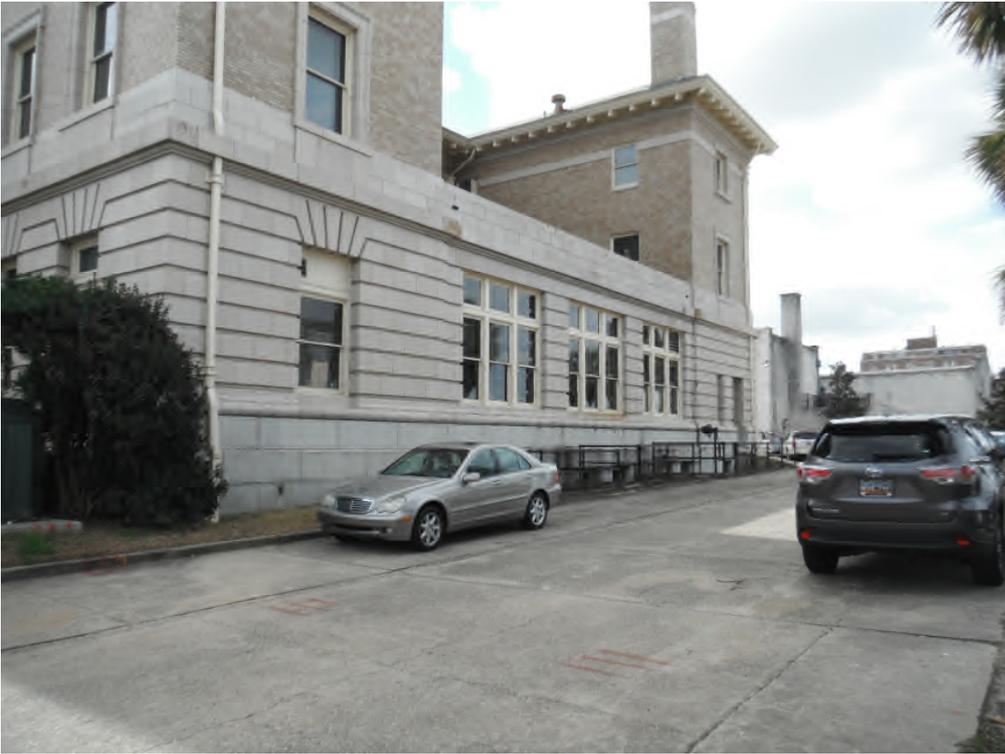
Photograph #4	Remarks

Rear elevation (North) consisting of granite foundation, sandstone and brick construction with personnel building access (northwest corner) and paved concrete area at the rear which is used for parking

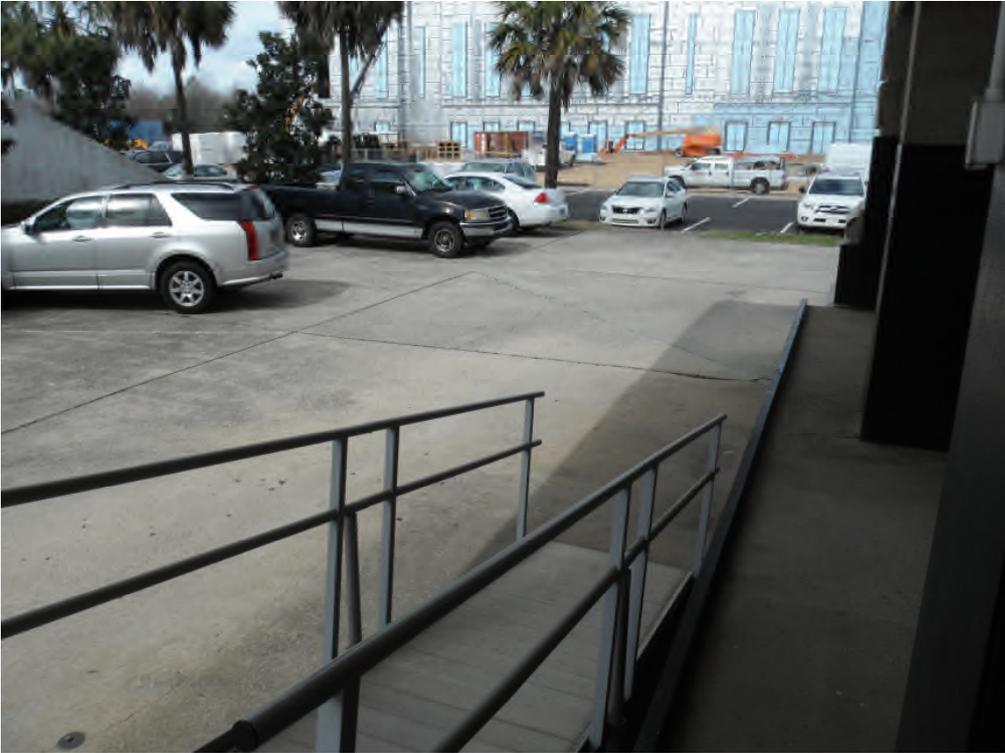
Photograph #7	Remarks

Cracked and worn concrete pavement at west parking area and ADA handicap access ramp entrance leading to former post office and loading dock currently used as private lawyer's offices entrance

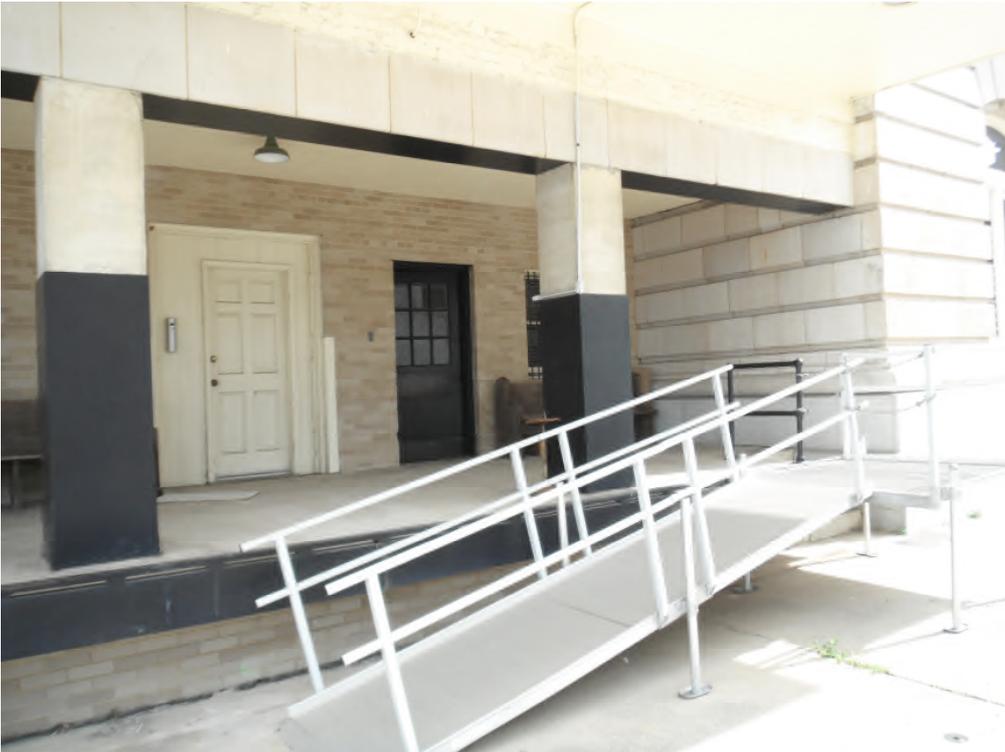
Photograph #8	Remarks

Northwest corner building access with ADA handicap accessible ramp.

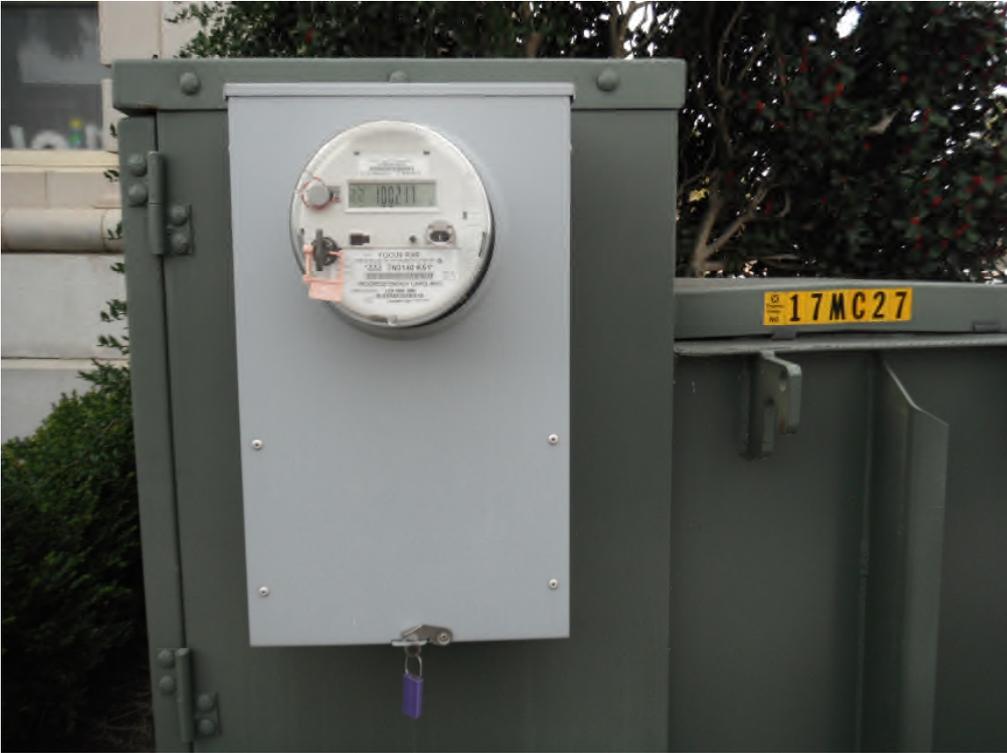
Photograph #9	Remarks

Electrical pad mounted Progress Energy transformer at the east side of the building servicing facility

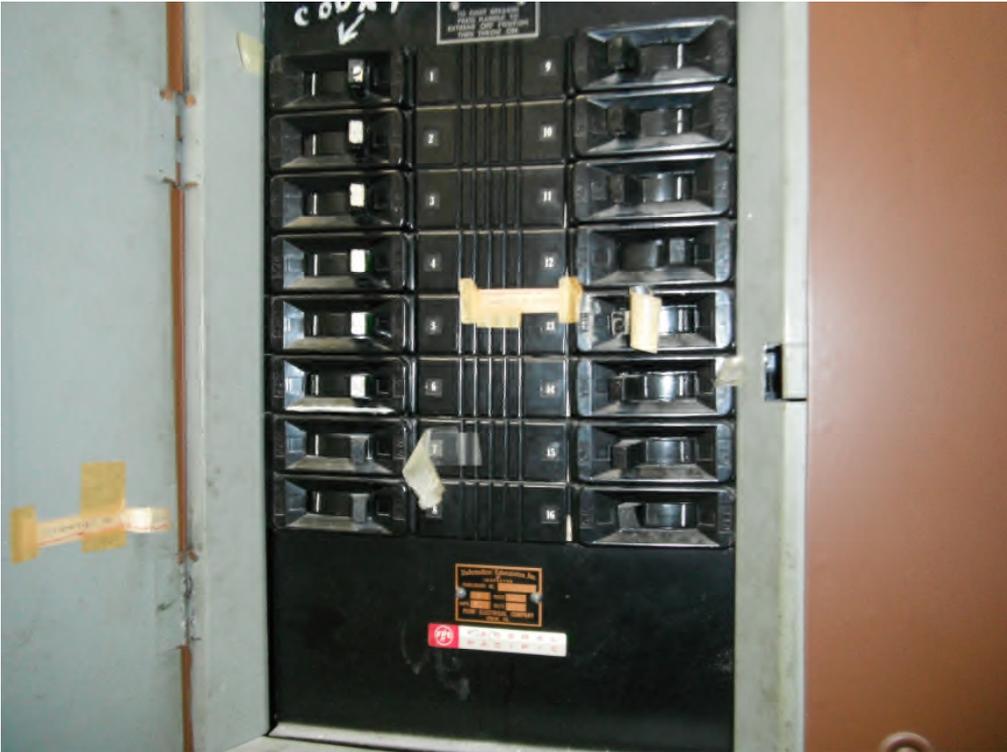
Photograph #10	Remarks

The original electrical system appears to be in poor condition. The Federal Pacific panel boxes are antiquated and outlets are not grounded along the walls and are too few in number to meet the intended future demand of a university building. A complete overhaul of the electrical system is required for safe operation of lighting, outlets and mechanical equipment. Low voltage communication system will need to be added to support its future intended use.

Federal Pacific panel box for electrical distribution

The electrical system including Federal Pacific switch gear, panel boxes, and insulated electrical conductors does not meet the National Electric Code (NEC) 2014. GS2 understands that it is proposed to completely gut the electrical system and replace with a new electrical system.

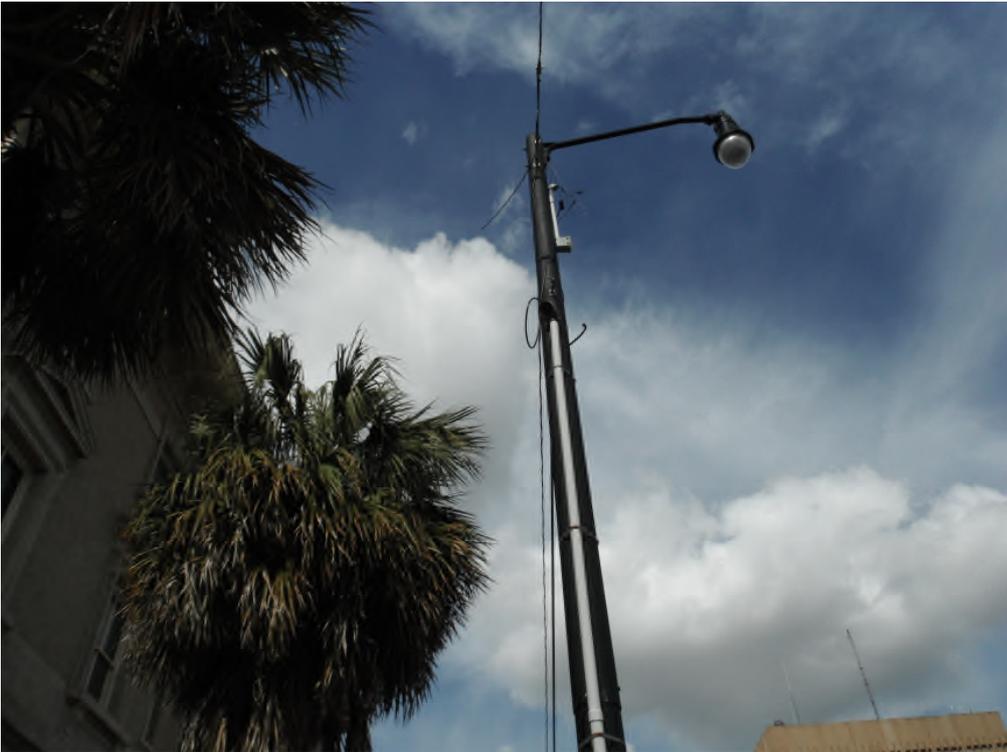
Photograph #12	Remarks

Overhead power line and lamp post on Irby Street.

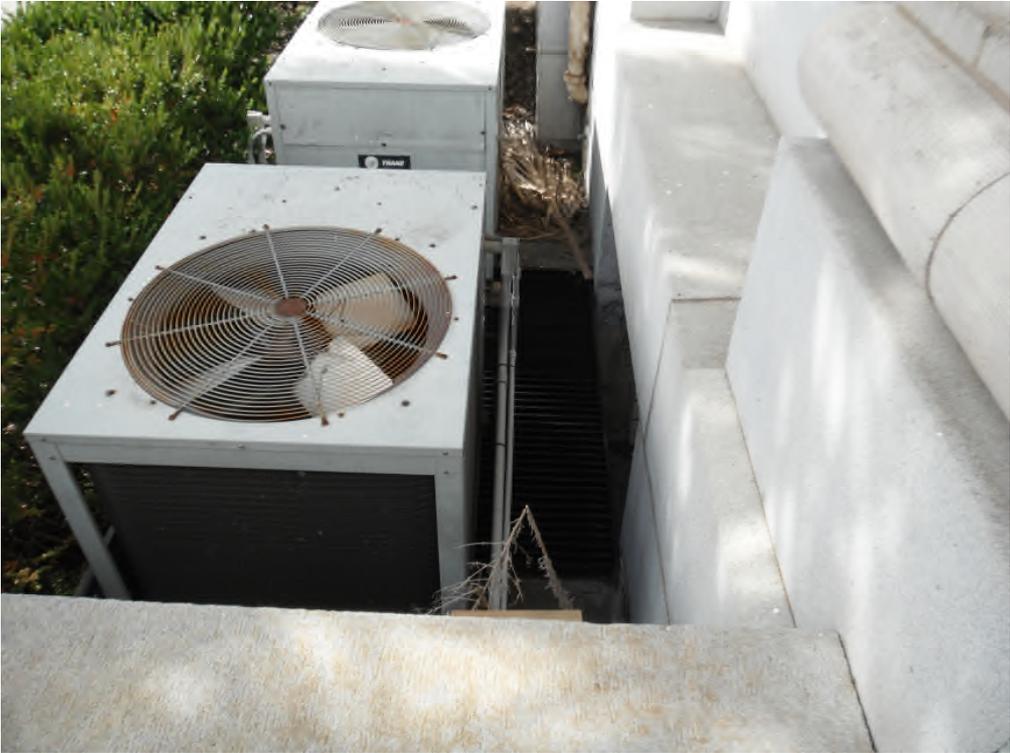
Photograph #13	Remarks

10 Ton cooling, Trane HVAC 1994 vintage units adjacent to the front entrance

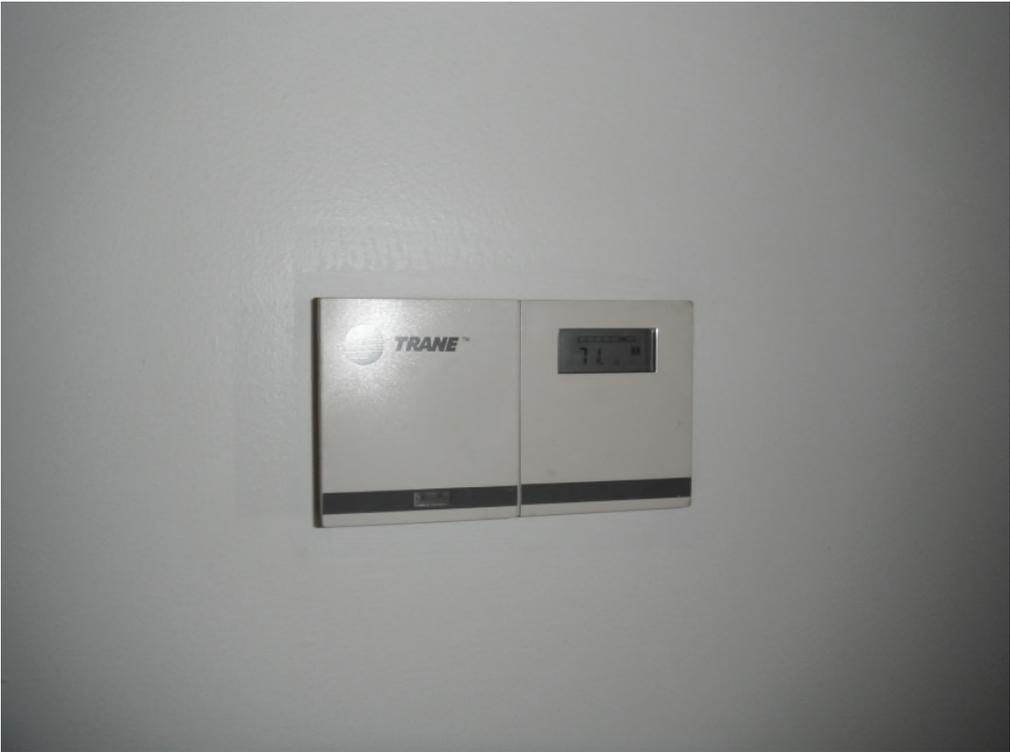
Photograph #14	Remarks

The control systems for the building appeared to operate in average condition and no obvious problems were reported or observed. (See Photo #14)

3 rd Floor Trane thermostat in corridor.

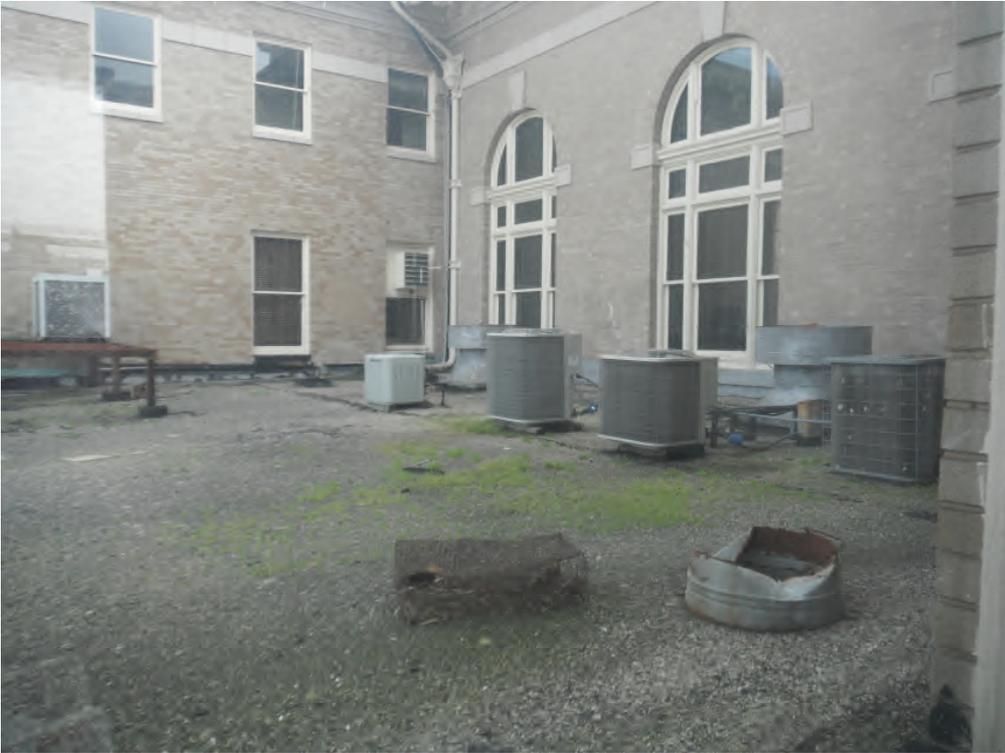
Photograph #15	Remarks

Five heat pumps located on second floor flat roof.

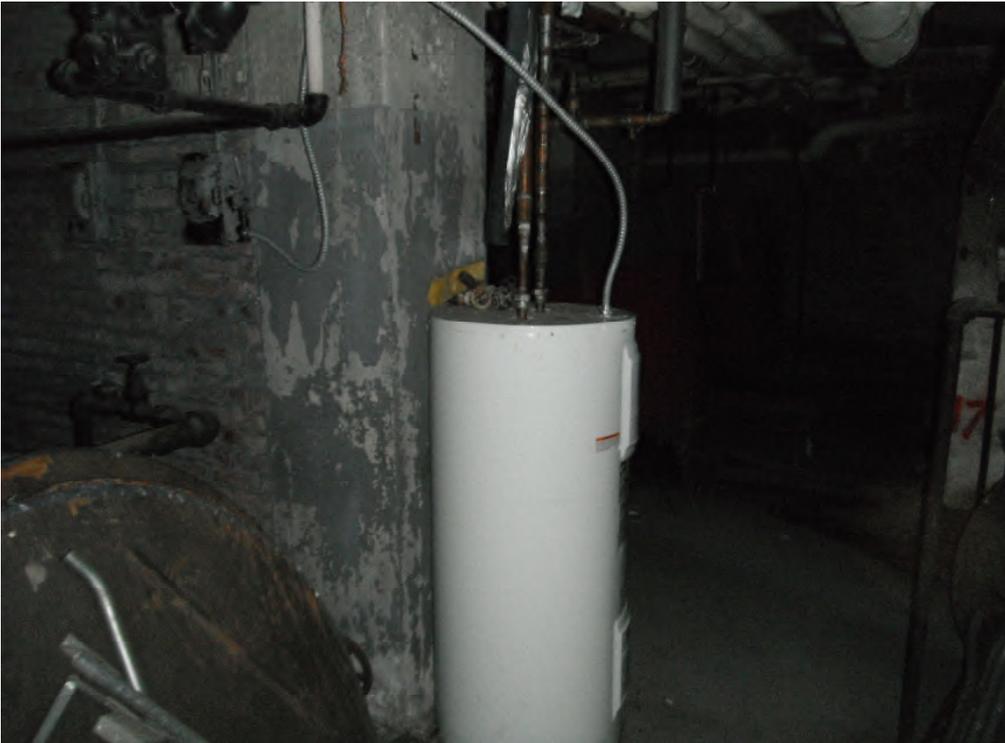
Photograph #16	Remarks

52-gallon electric water heater in basement services restrooms and break room.

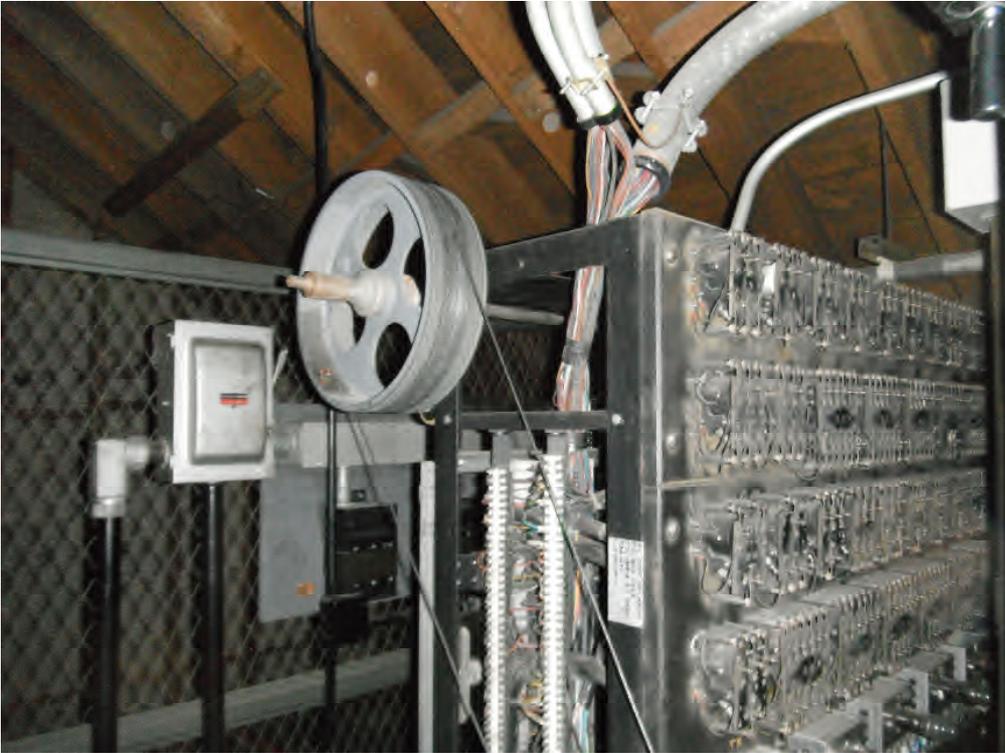
Photograph #17	Remarks

Traction elevator with points and contact controls in the attic space, maintenance provided by Southern Elevator.

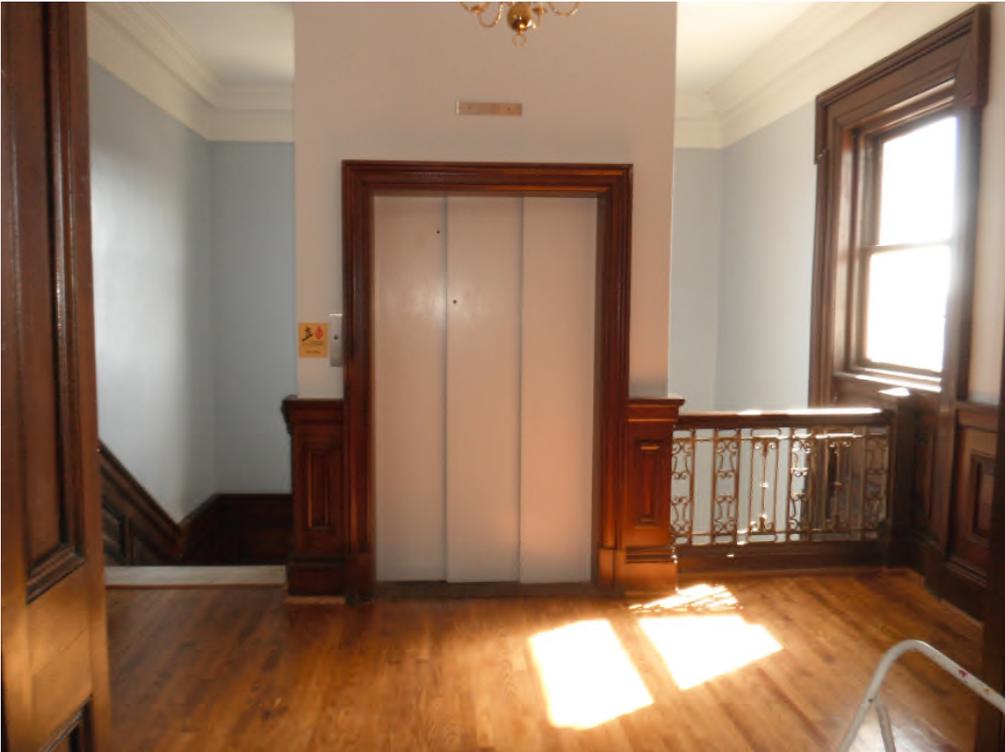
Photograph #18	Remarks

Elevator stop at third floor. Cab rated for 1500lbs and has current certification.

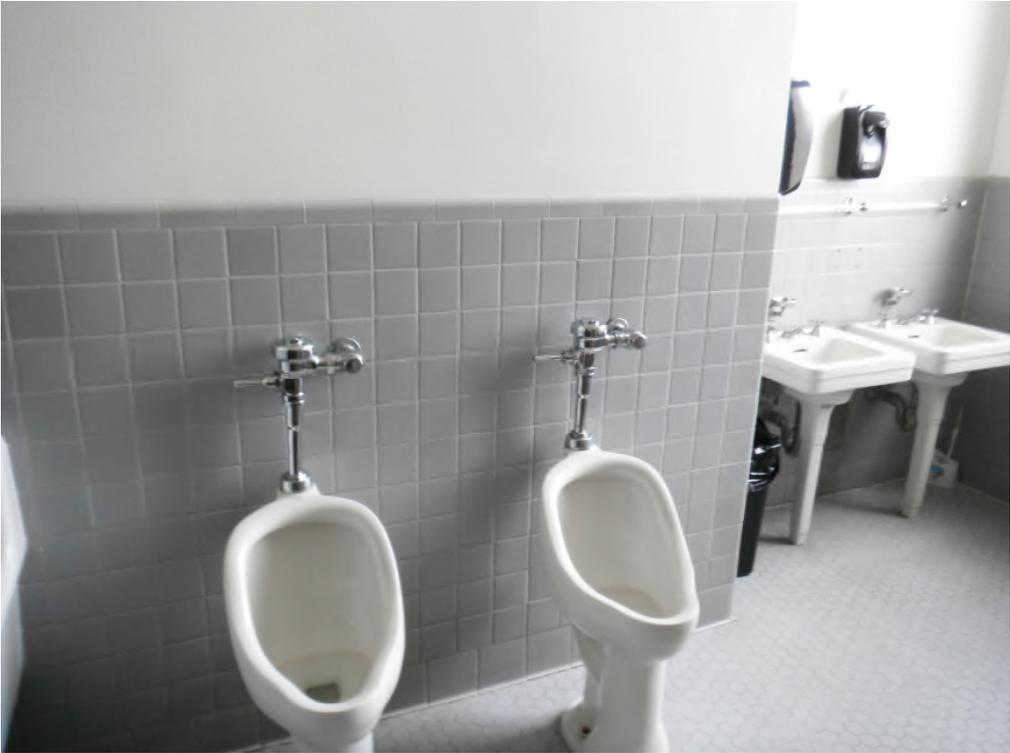
Photograph #19	Remarks

Fixtures appeared to be in average condition but not code compliant and would not meet ADA handicap requirements as shown in the ICC A117.1-2009 "Accessibility and Usable Buildings and Facilities" manual. (See Photo #19). Hot water production appears to not be adequate for the second-floor restrooms. An upgrade has been proposed to meet the 2015 IPC and ADA requirements during the renovation process.

A photograph of a men's restroom. The wall is covered in light-colored square tiles. Two white urinals are mounted on the wall. In the background, there are two white pedestal sinks with chrome faucets. A black soap dispenser is mounted on the wall above the sinks. The floor is a light-colored carpet.	Men's second floor restroom

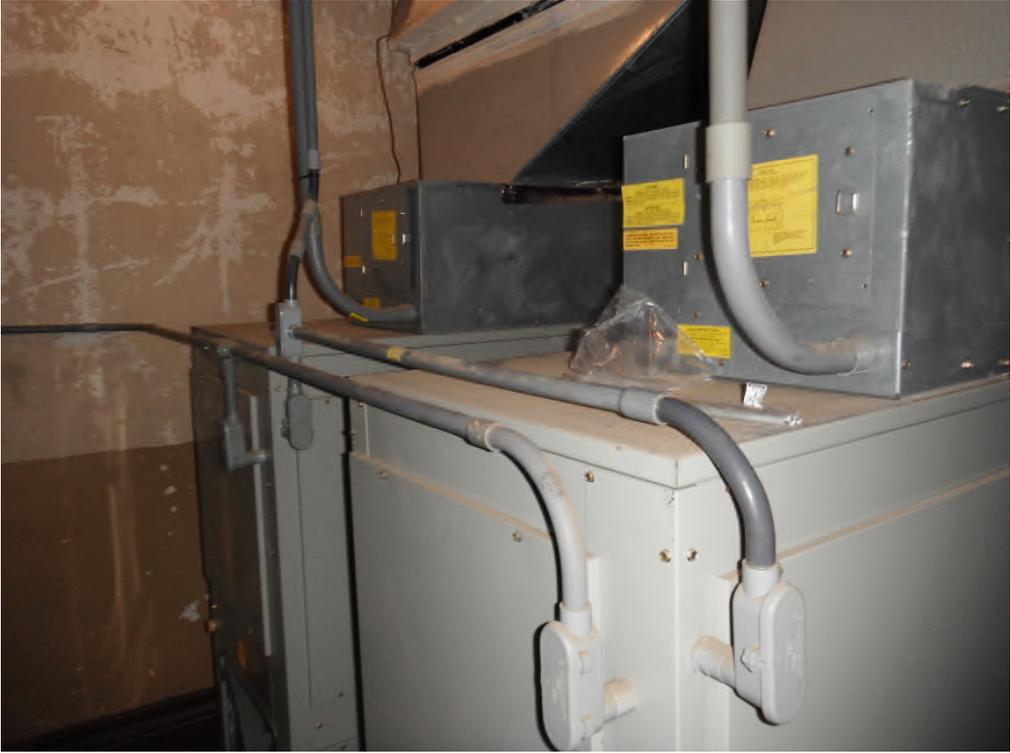
Photograph #20	Remarks

A photograph of a mechanical room. Several large, grey metal Trane air handlers are visible. They are connected to a network of grey ductwork and pipes. The room has a concrete floor and a wall with some peeling paint. A metal railing is visible in the foreground.	Trane air handlers in the mechanical room. at second floor

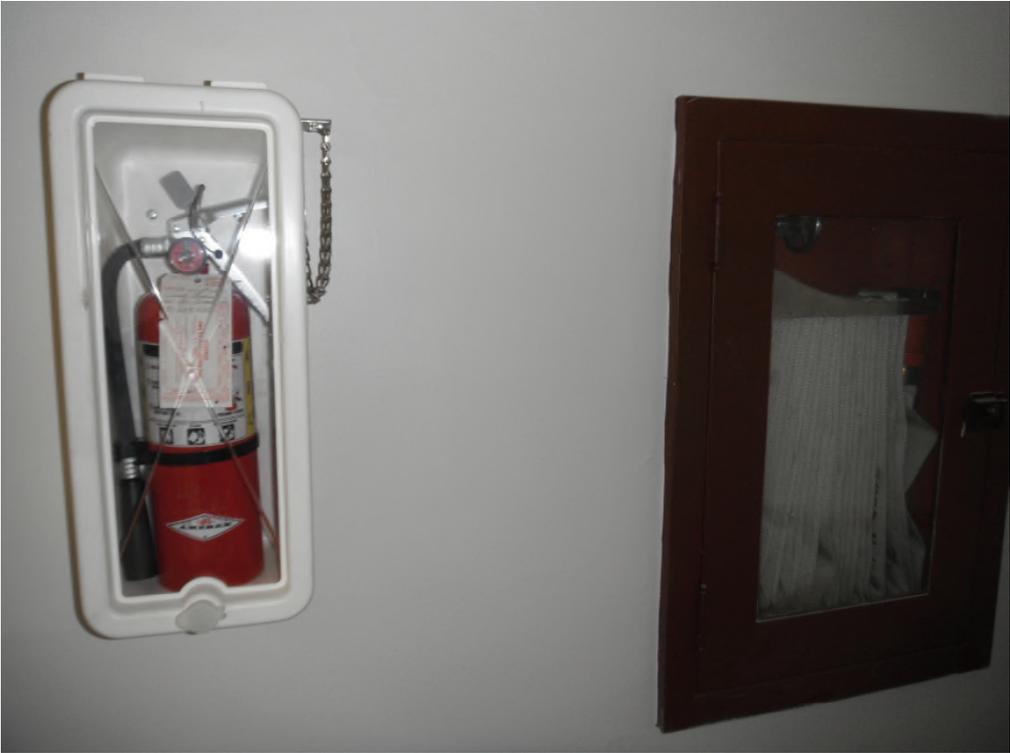
Photograph #21	Remarks

Smoke Detectors, Fire Extinguishers and Other Equipment: No smoke detectors, pull stations, strobe with horns, and fire alarm system were observed in the facility. Fire extinguishers were observed in the hallways with fire hoses at stand pipes. Emergency lights and exit signs were only observed at the first-floor corridors serving the legal offices. (See Photos #21 and #22).

The fire life safety and fire protection systems appear to be inadequate and in need of an upgrade to meet its intended future use.

Fire Life and Safety System stand pipe with fire hose and fire extinguisher on the third floor

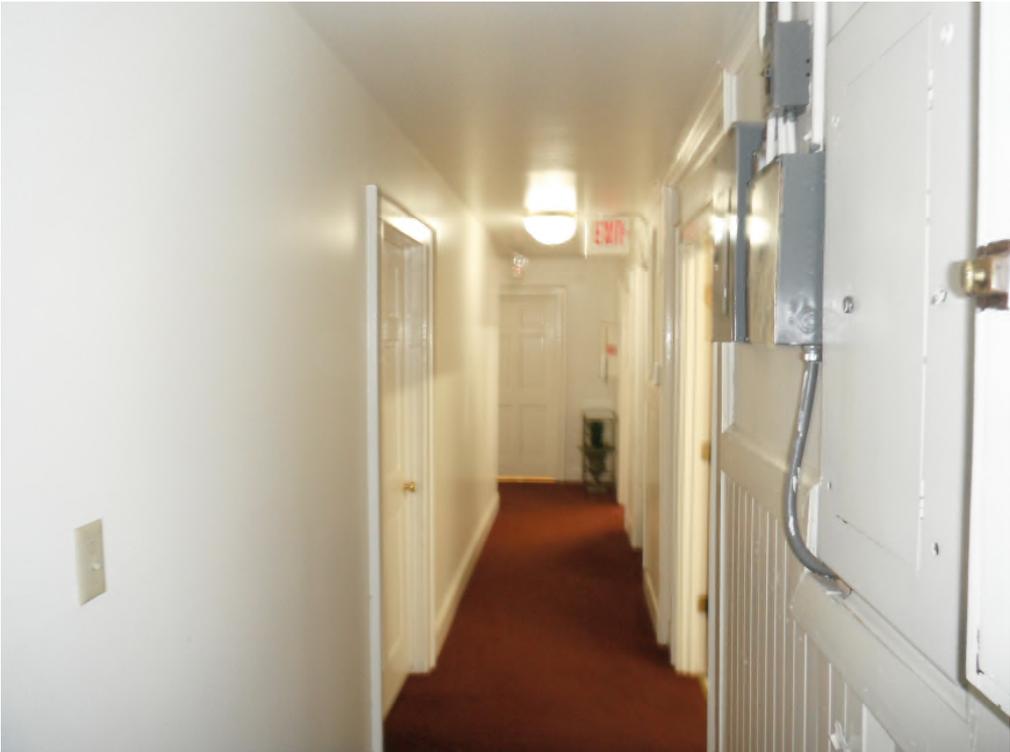
Photograph #22	Remarks

First floor corridor with emergency exit light

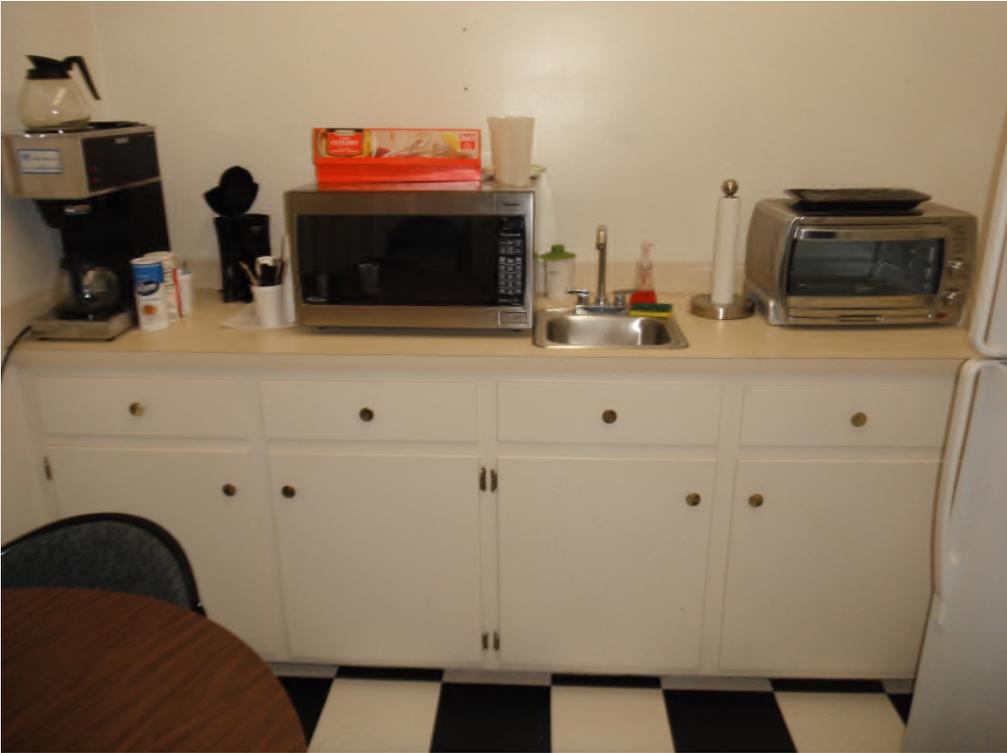
Photograph #23	Remarks

A kitchen area with white cabinets, a microwave, a sink, a coffee maker, and a toaster. The floor is black and white checkered. A wooden table and a blue chair are partially visible in the foreground.	First floor breakroom

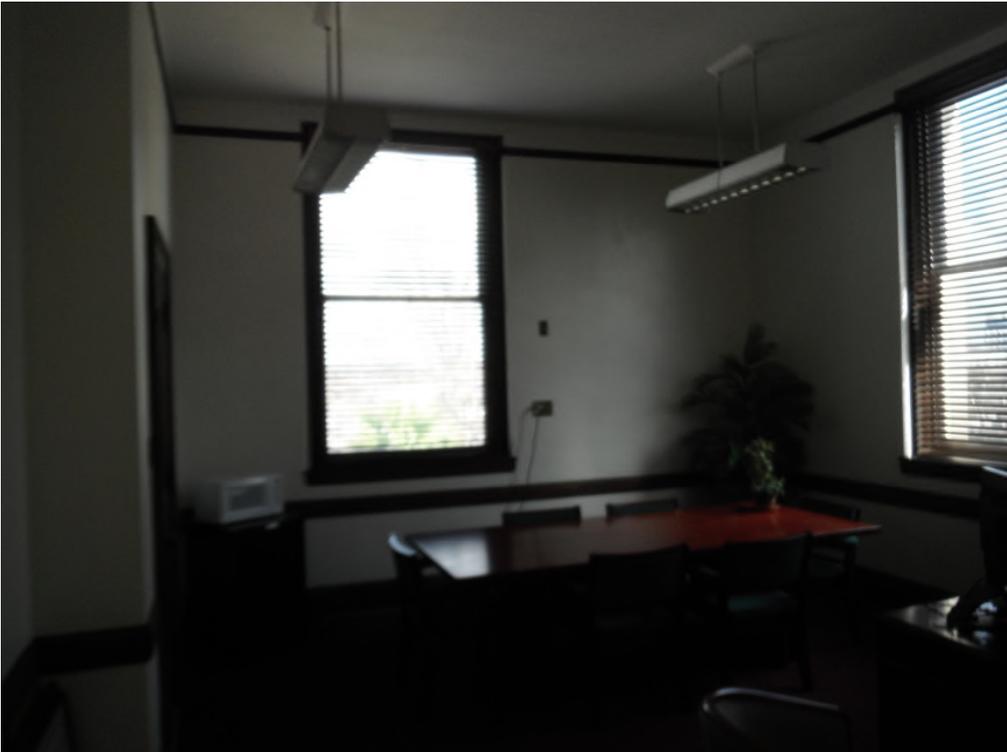
Photograph #24	Remarks

A dark conference room with a long table, chairs, and large windows. The room is dimly lit, with light coming from the windows. A potted plant is visible in the background.	Rear office on second floor

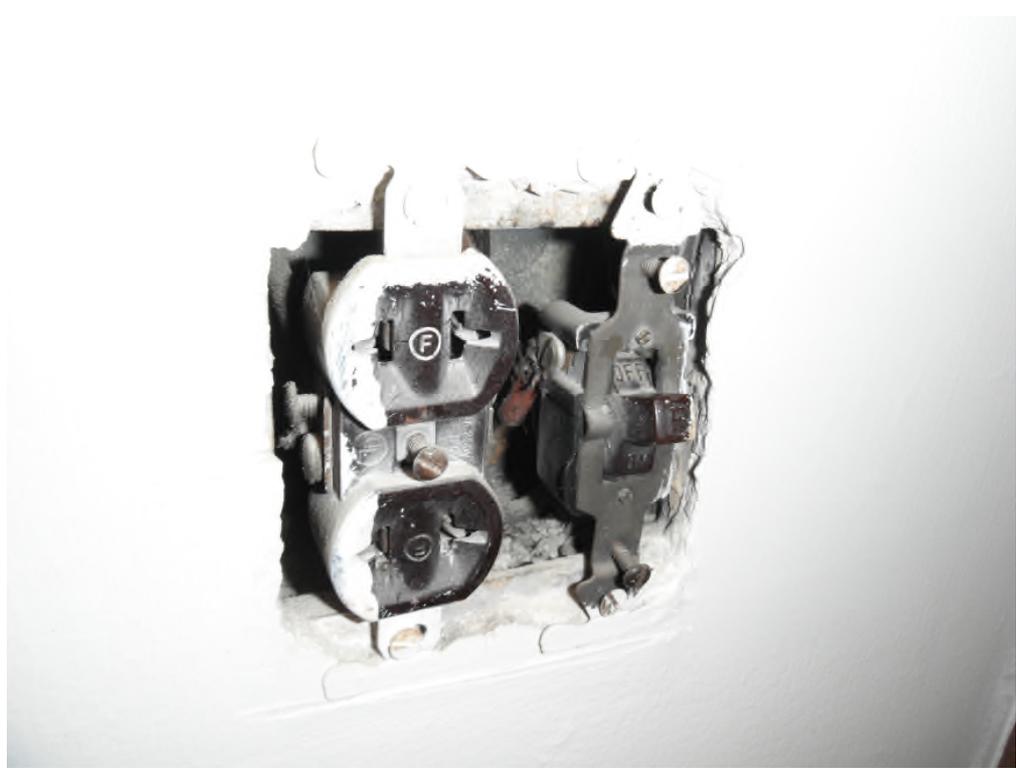
Photograph #25	Remarks

Electrical switch and outlet missing its face plate and outdated with no ground

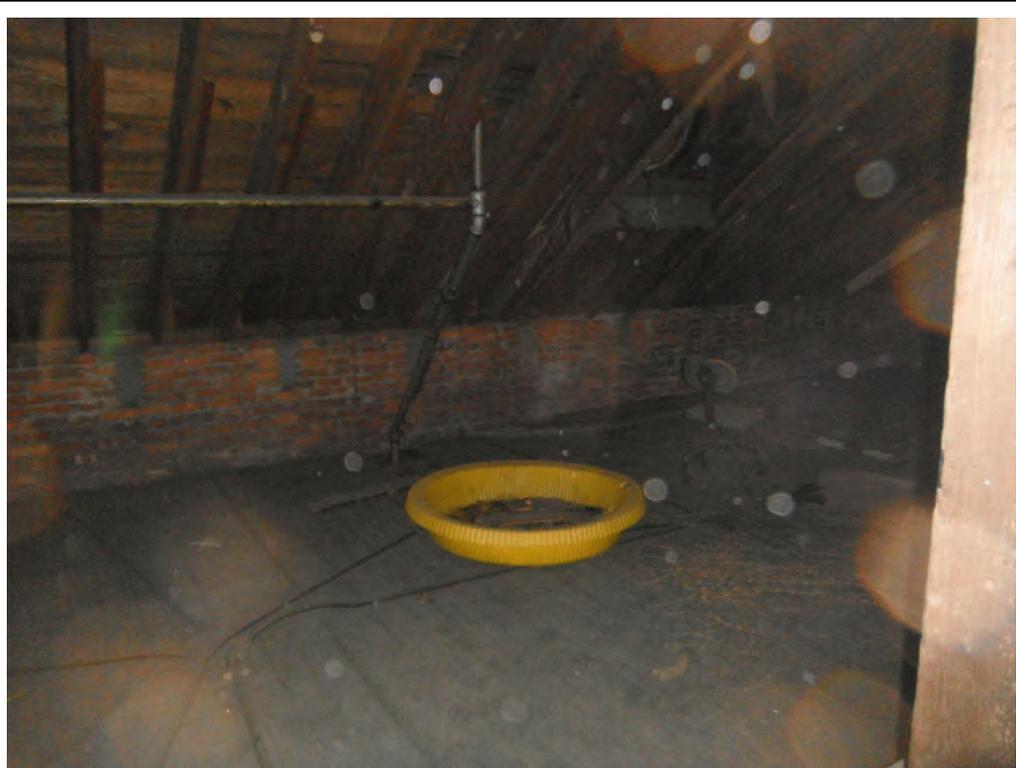
Photograph #26	Remarks

Based upon our observations, the roofing system is in poor condition. Slate shingles were observed to be loose and missing over the rear elevation ridges. Maintenance has placed kiddie pools to catch roof leaks in various locations in the attic space. (See Photo #26).

Attic space with kiddie pools placed to catch roof leaks

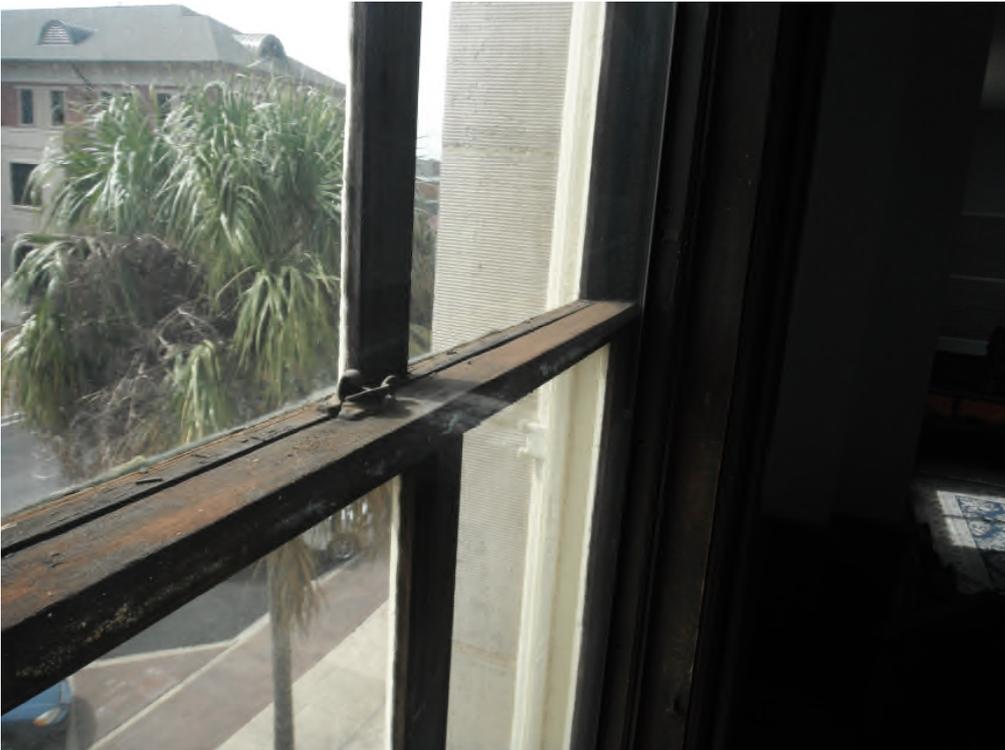
Photograph #28	Remarks

Window System: The double hung single pane wood windows counter balanced with weights were observed in the offices, restrooms and lobbies. A second flexible pane has been added to the interior side of the windows for energy efficiency. Interior transoms exist over the doors and a few have mechanical ducts in them.

Based upon our observations, the window system generally appears to be in average condition. No obvious defects were noted or observed.

Double hung single pane window with custom additional pane at inside of window sill for energy efficiency

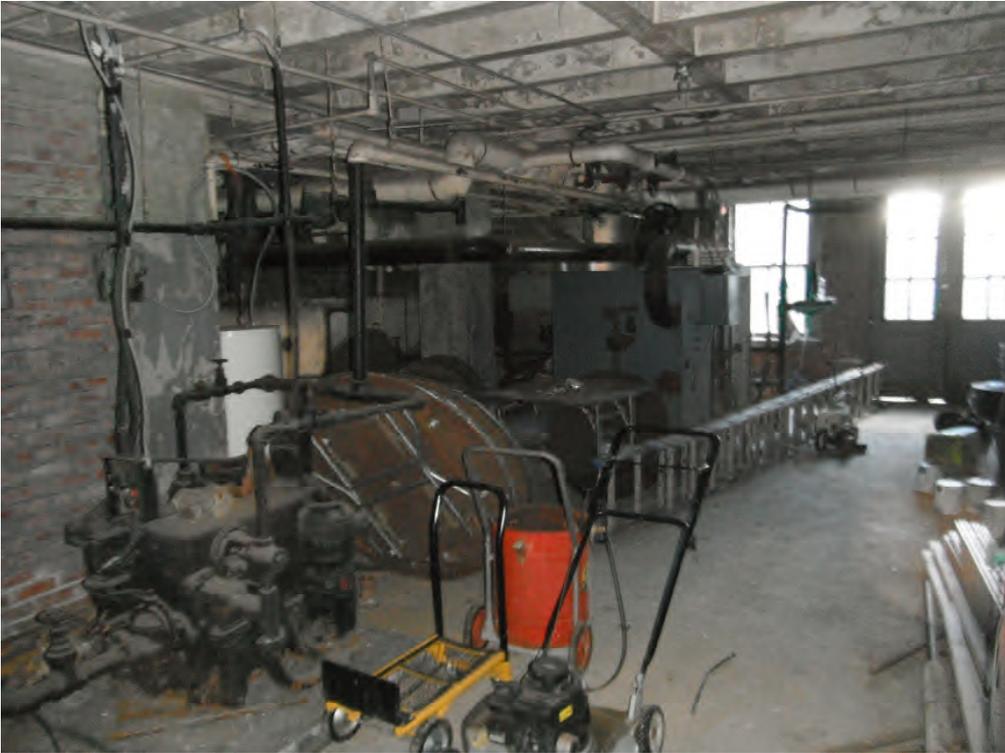
Photograph #29	Remarks

One storage room in the basement houses cans of paint and is used for building maintenance. The rear boiler room has lawn maintenance equipment such as lawn mowers and edger's and associated motor oil containers. Basement walls were observed to have peeling paint in many areas which may contain lead and be a health risk if not removed. Insulation on the boilers and on the steam piping may contain asbestos material and is reportedly being evaluated by Francis Marion University. Other than the potential for lead based paint and asbestos containing insulation, no other hazardous material was observed on the premises. (See Photos #29 and# 30).

Gas fired boiler in basement

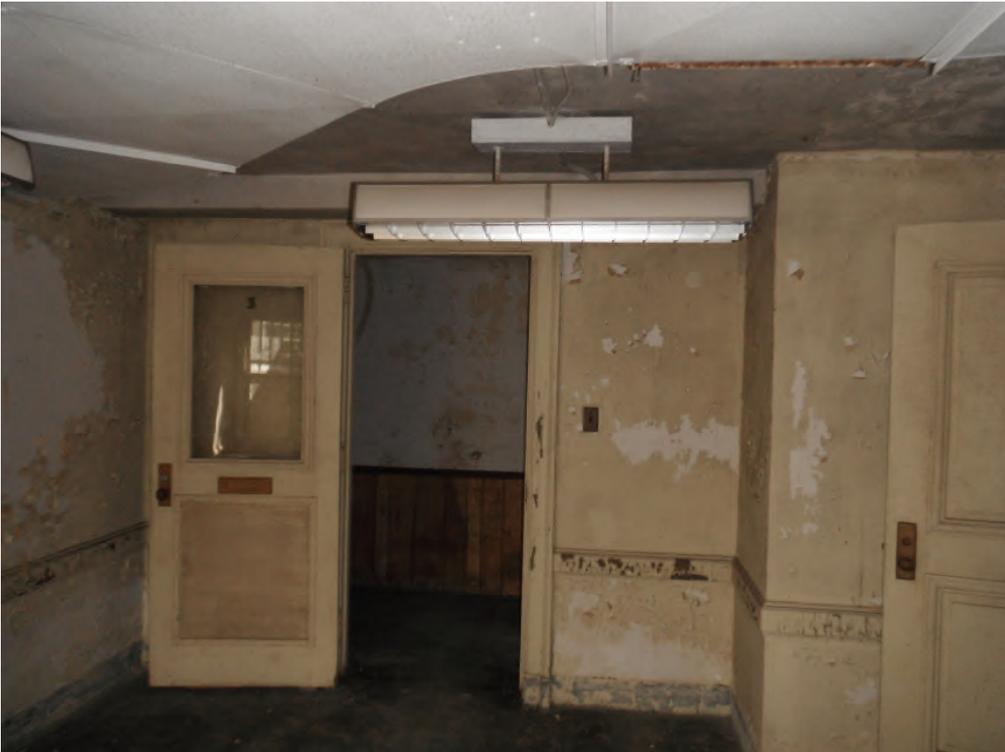
Photograph #30	Remarks

Basement offices abandoned with peeling paint which may be lead based. No air conditioning is currently provided to the basement.

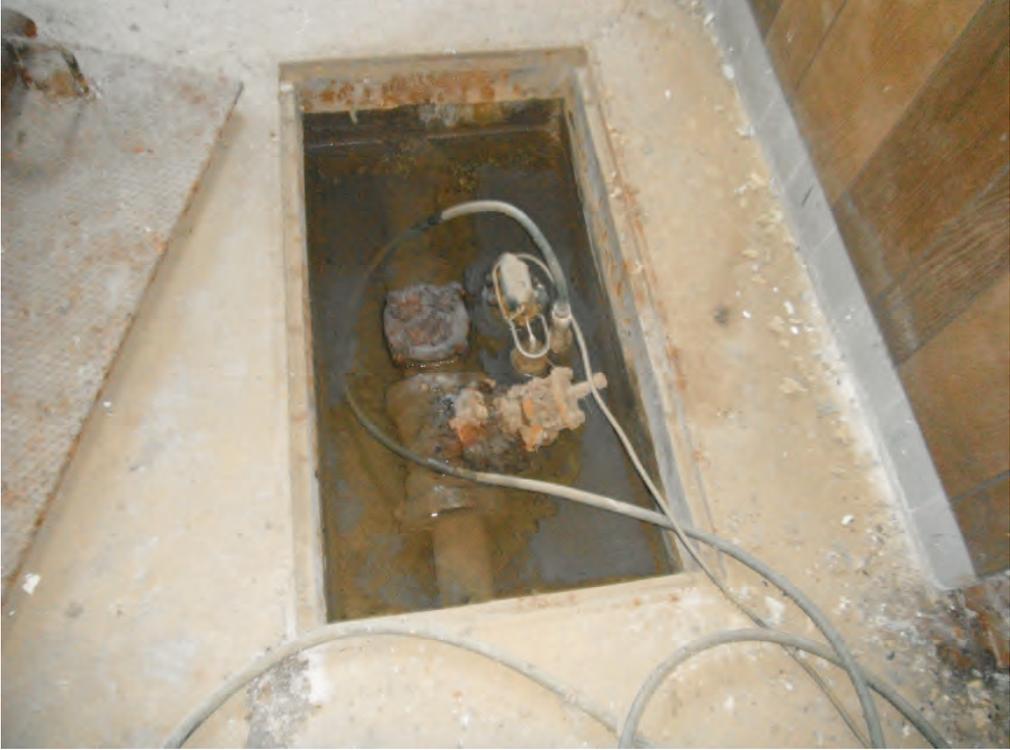
Photograph #31	Remarks

No indications of ponding or flooding were observed at the site, sump pits in the basement were observed to be full of water. (See Photo #31).

Sump pit in basement full of water
