**REPORT OF
BUILDING CONDITION ASSESSMENT PHASE I**

**FORMER POST OFFICE AND COURTHOUSE
201 W. EVANS STREET
FLORENCE, SOUTH CAROLINA**

Prepared by:
GS₂ ENGINEERING, INC.
241 Business Park Blvd
Columbia, South Carolina 29203
GS 2 Project No.17-12967-F
March 3, 2017

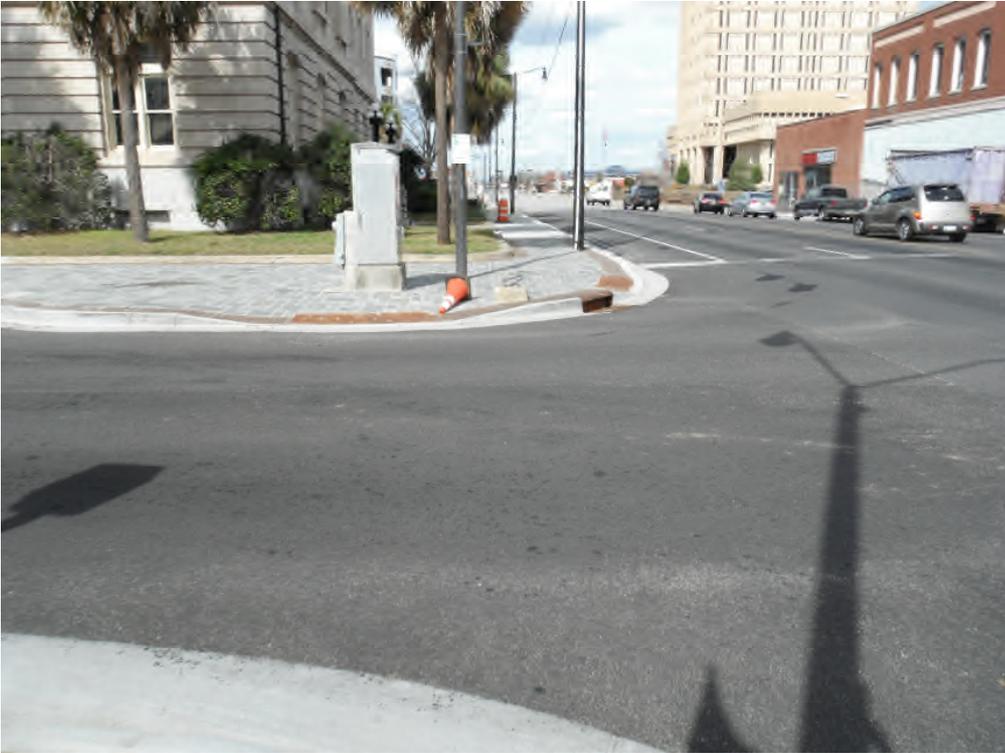
Photograph #5	Remarks

A photograph showing a street intersection. In the foreground, there is a concrete curb and a catch basin. A paved sidewalk runs along the street, marked as ADA handicap accessible. In the background, there are several buildings, including a large multi-story building and a smaller brick building. A few cars are visible on the street.	East property line at intersection of Irby and Evans Street, catch basin and ADA handicap accessible sidewalk

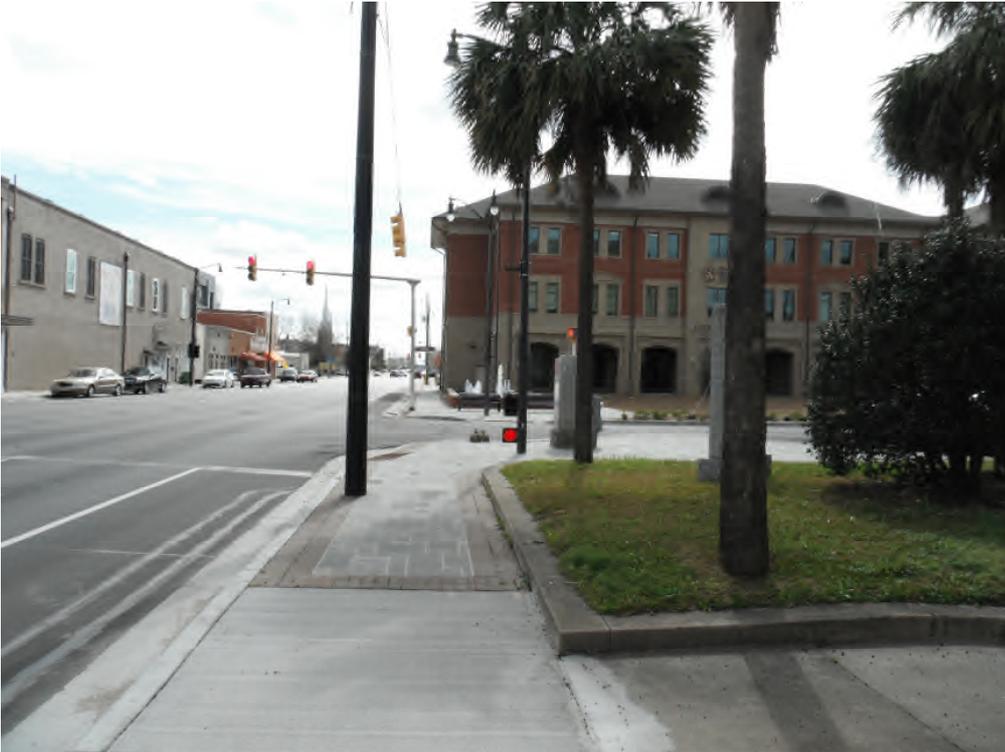
Photograph #6	Remarks

A photograph showing a view of Irby Street. The street is paved and has a concrete curb. A utility pole is visible on the left. In the background, there is a large brick building with many windows, identified as the Francis Marion University Facility. The street is lined with palm trees and other vegetation.	South and east property line along Irby Street with the Francis Marion University Facility across W Evans Street

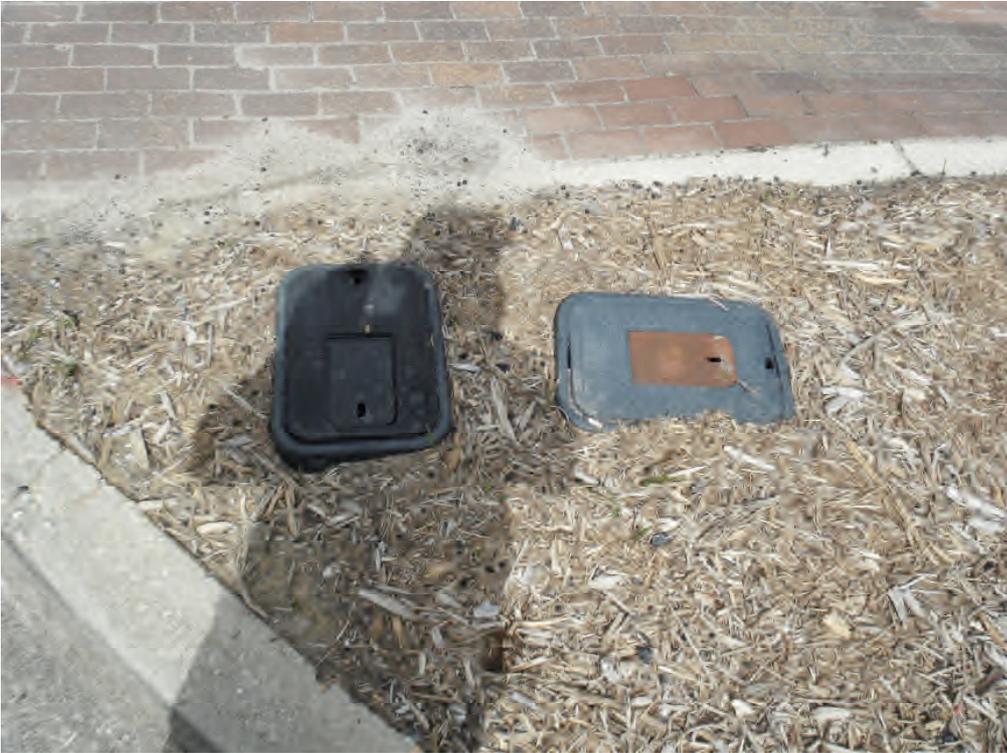
Photograph #11	Remarks

Water utility boxes along W Evans Street

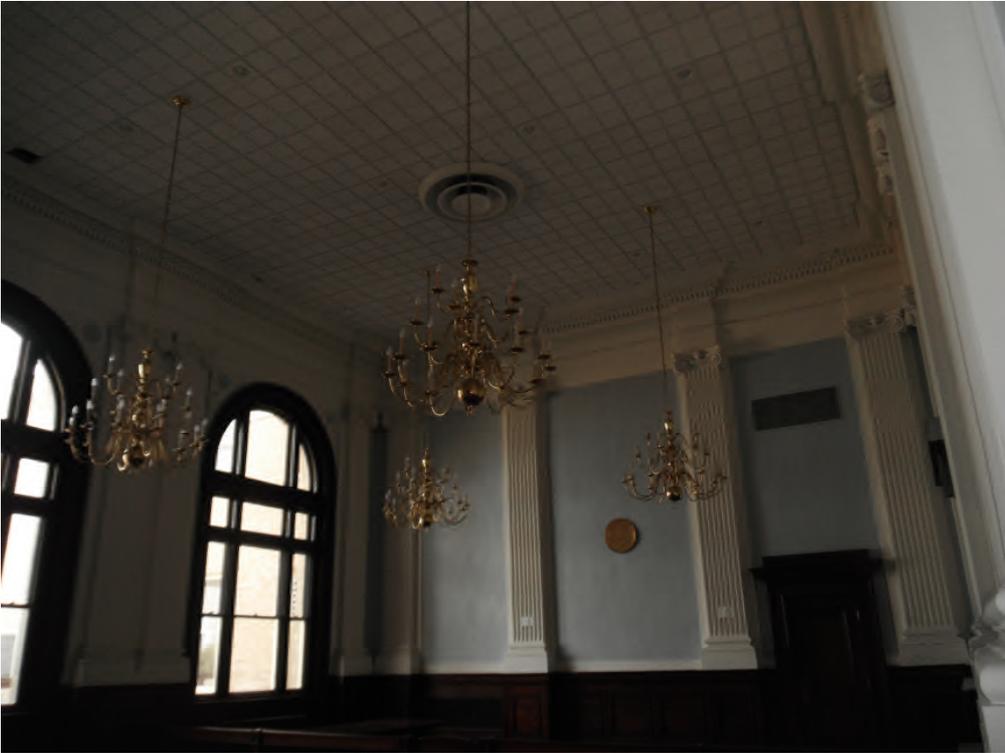
Photograph #27	Remarks

Courtroom on second floor
